# Agenda Report

## New Business - Development and Environmental Services Group

J.2.

Authorization from the Board on Improvements at the Ritch Grissom Memorial Wetlands

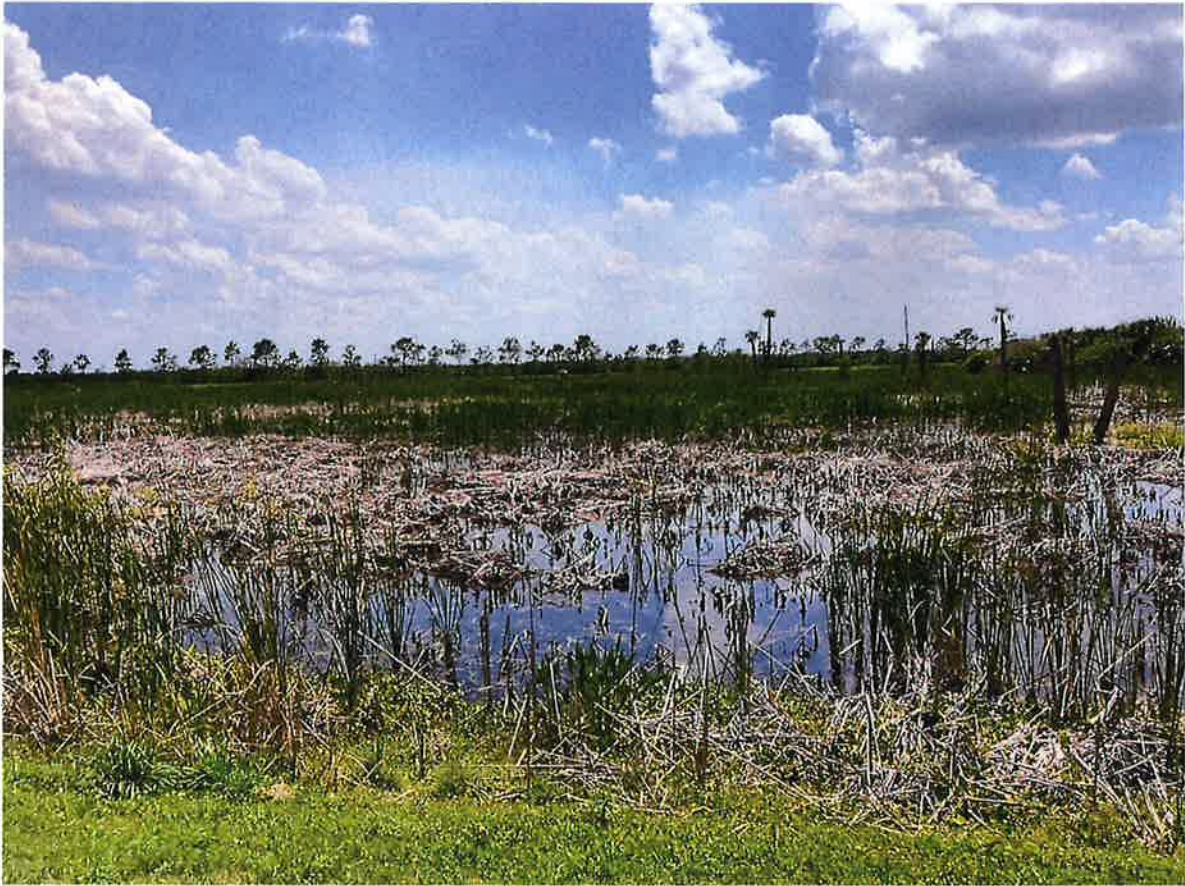
Dead and decaying cattails at Cell 3, Photo Station 24; facing south.

- Cease spraying of herbicide on cattail stands;
- Remove dead, decaying cattail stands;
- Herbicide spray monotypic areas of torpedo grass, allow to die back, then remove dead vegetation and underlying organic material;

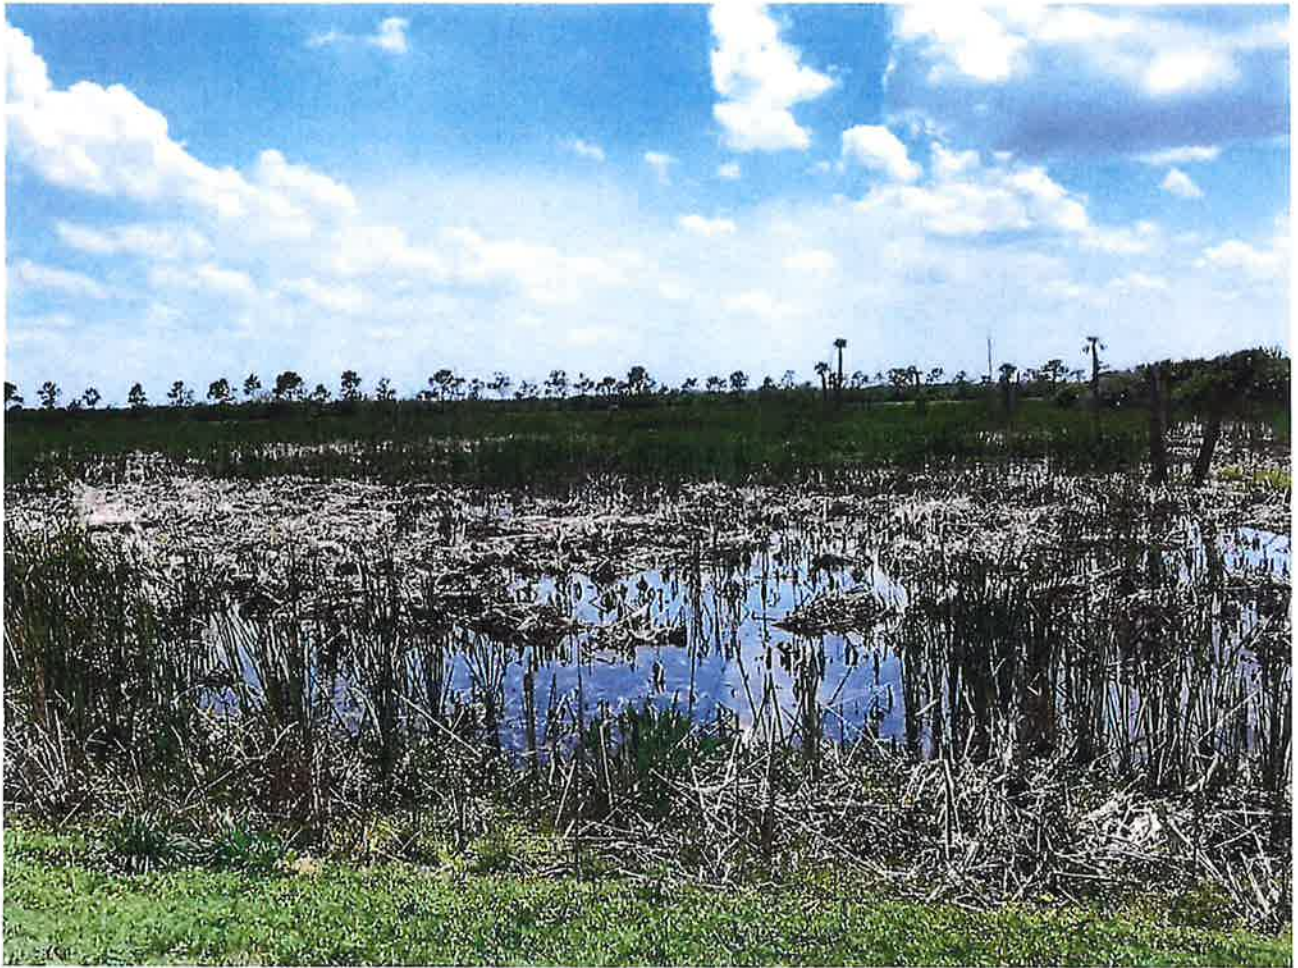
Dead and decaying cattails at Cell 3, Photo Station 24; facing south.

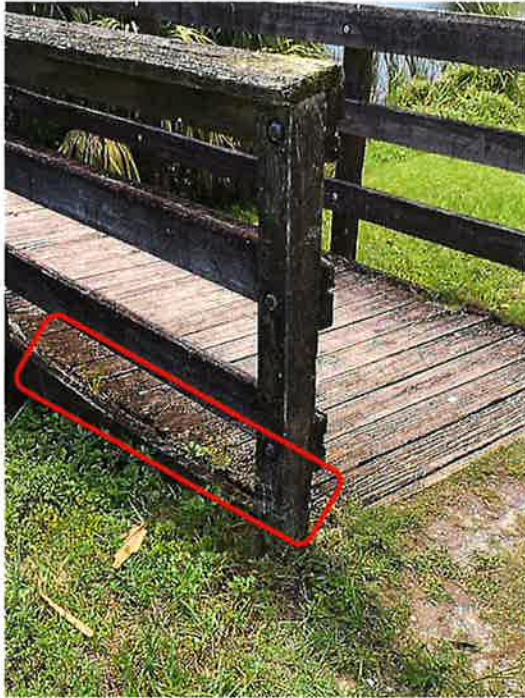
Picture 1

Damaged wood planks from weather and moisture.

1. The structure should be prohibited to the public in any case, as coordinated previously. The current conditions can cause human injury or death. Operation of the structure can continue after all the required repairs are performed or replacement of the structure.
2. Repair/replace all the wood railing in the structure.
3. Replace all wood floor planks.
4. Repair/replace stair girder and all defected wood beams.
5. Replace all rusted nails and bolts.
6. Replace all rusted and damaged Simpson connections (Hurricane ties and beam bucket connections).
7. Additional special inspection and analysis are required for the wood piers and columns. Visual inspection cannot guarantee the adequacy of the members.
8. Repair/replace wood stairs.

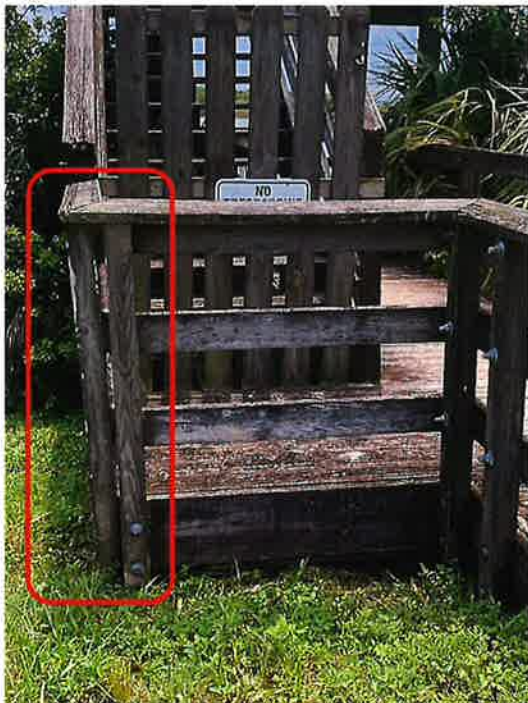
Picture 2

Bended railing posts.

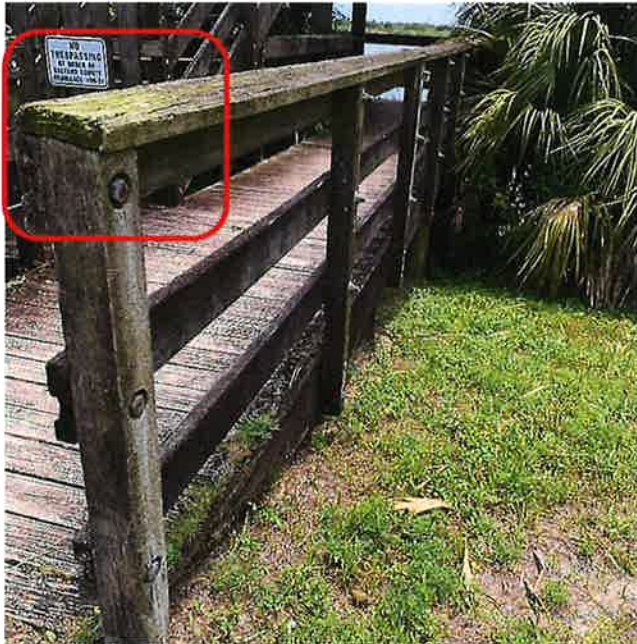
Picture 3

Damaged railing top plywood.

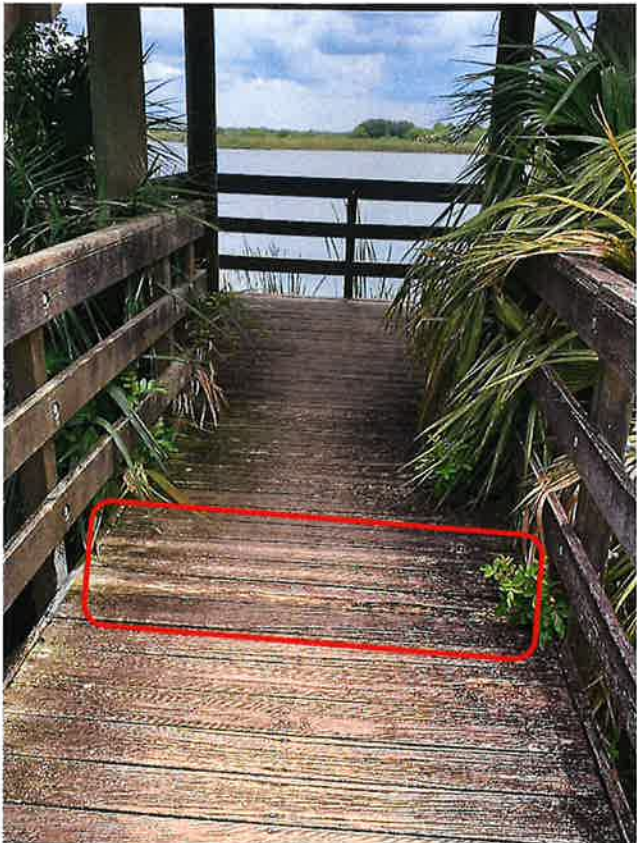
Picture 4

Damaged and "dry" floor planks.

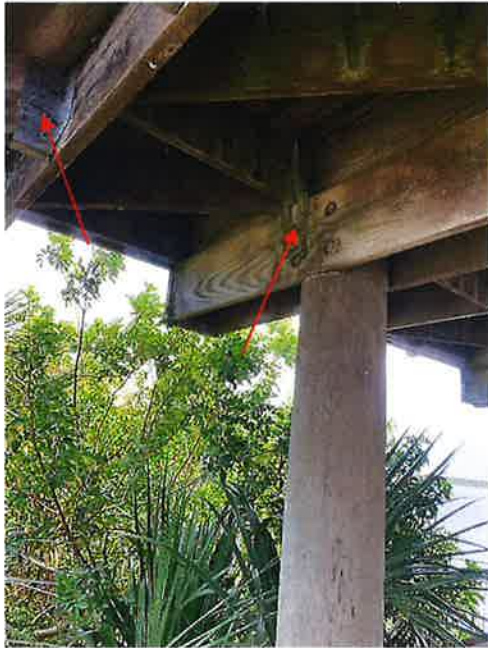
Picture 5

Rusted Simpson hurricane ties and floor beam connections  
nails all over the structure.

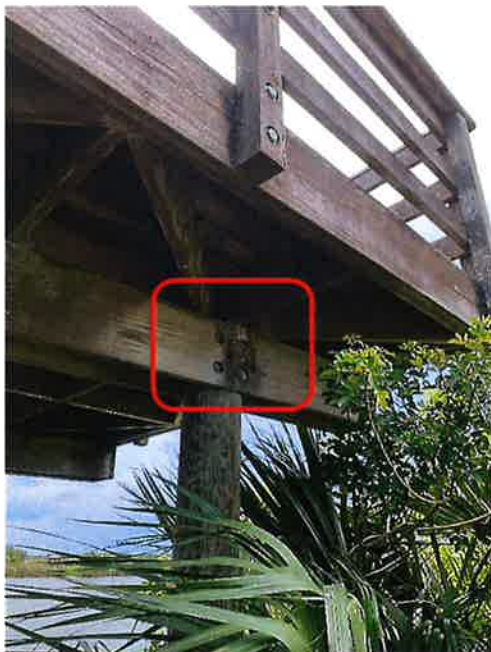
Picture 6

Rusted Simpson hurricane ties in multiple locations.

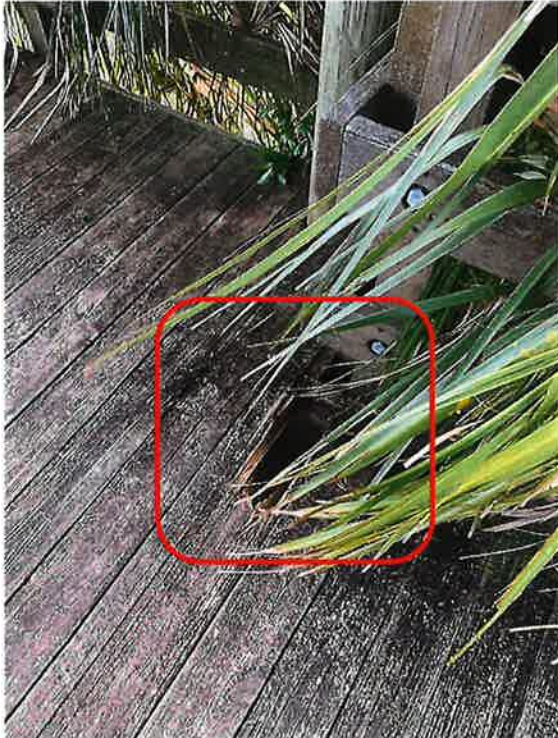
Picture 7

Broken floor plank. Many planks appeared at risk of collapse.

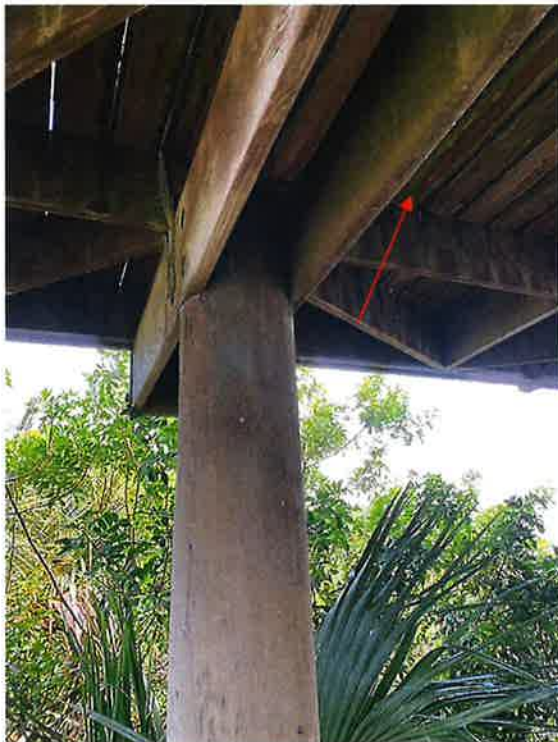
Picture 8

Excessive moisture and mold in multiple wood members.

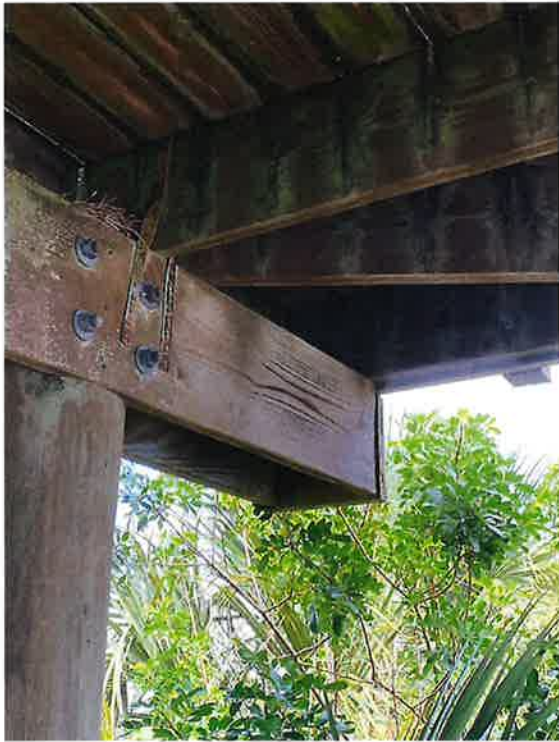
Picture 9

Excessive moisture and stains on wood members and rusted Simpson hurricane ties.

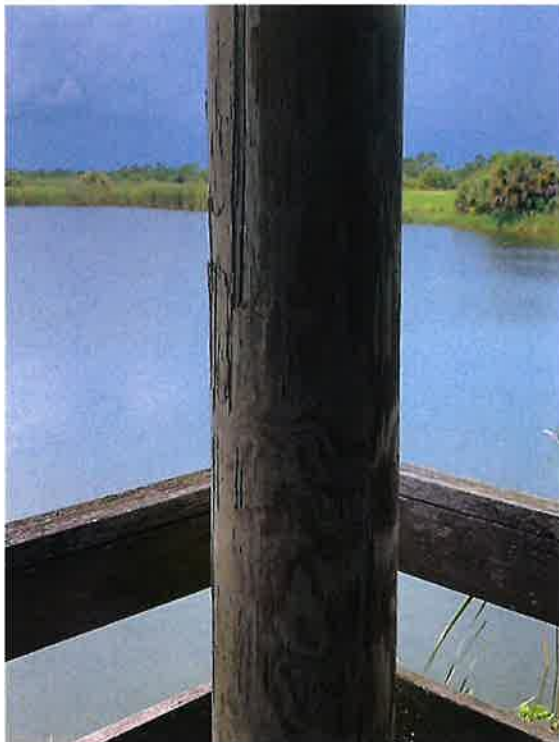
Picture 10

Surface damaged on the round wood column. Larger core shear cracks might occur.

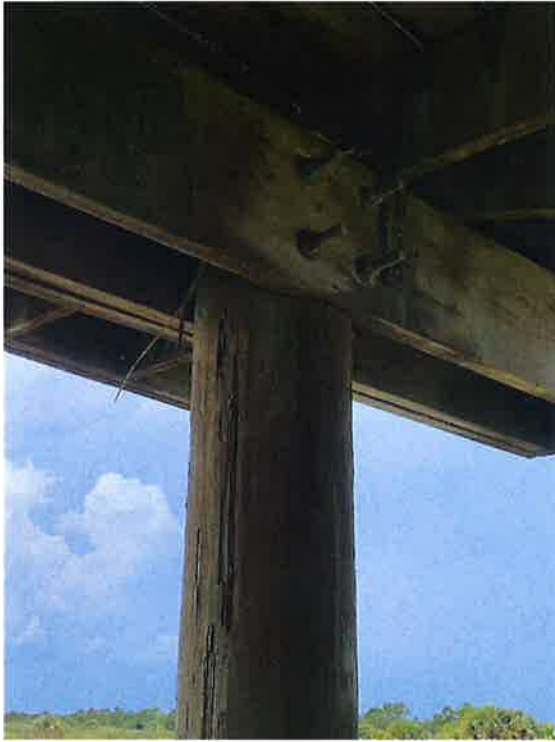
Picture 11

Wood column surface damage and rusted Simpson hurricane ties.

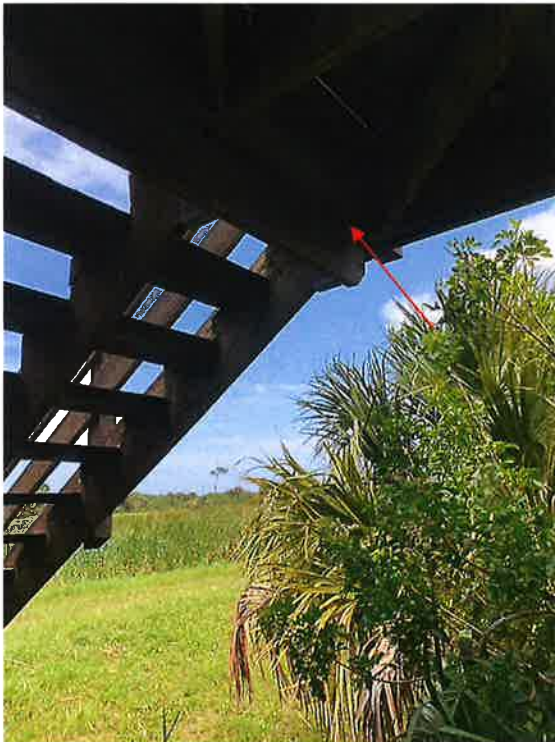
Picture 12

Damaged and deflected stair girder.

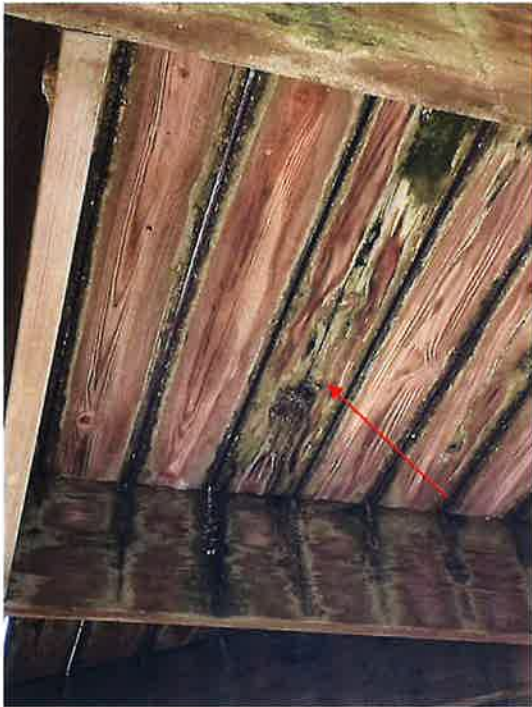
Picture 13

Cracked wood plank.

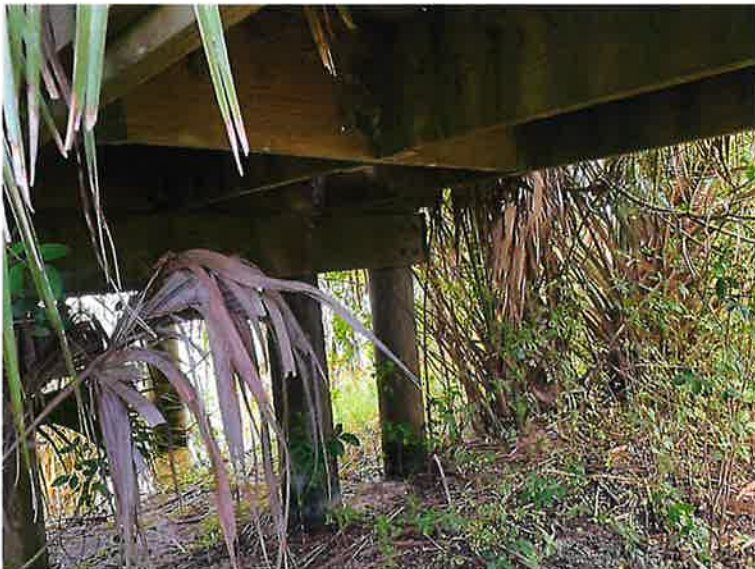
Picture 14

Round wood piles. Additional analysis and special inspection are required for the pile adequacy.

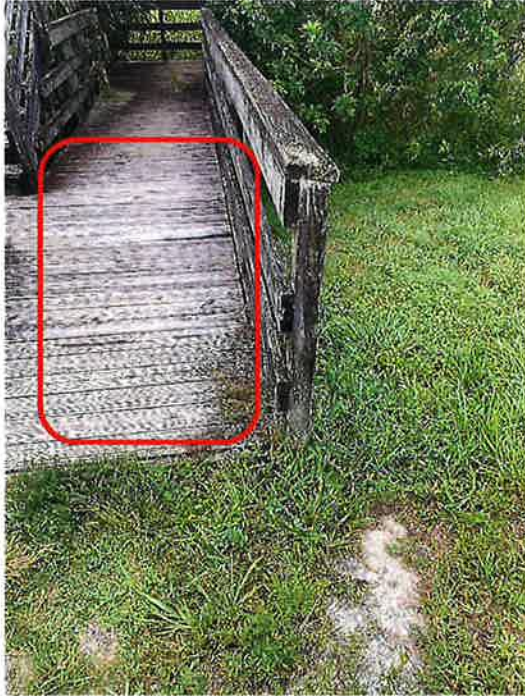
**Picture 1**

Damaged wood planks from weather and moisture.

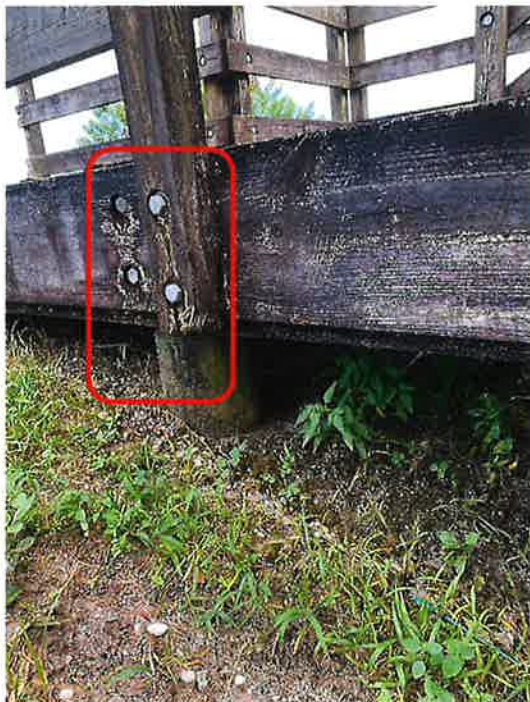
**Picture 2**

Multiple damaged railing posts. Shear cracks show at bolted connections.

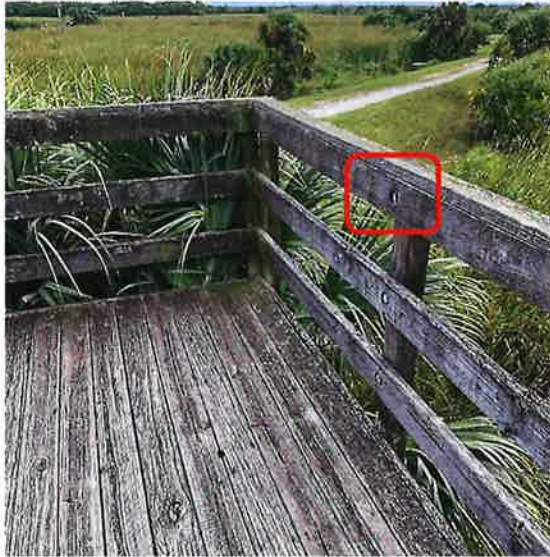
Picture 3

Missing railing bolt on the top deck railing.

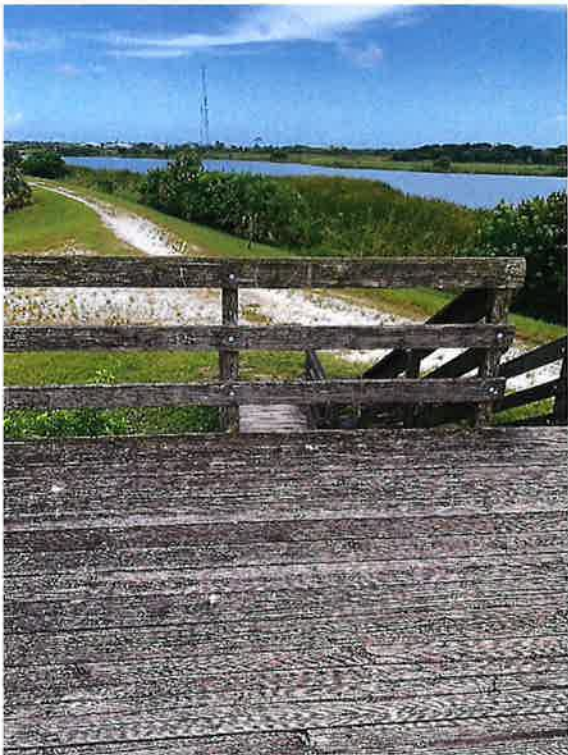
Picture 4

Damaged wood planks from weather and moisture. An excessive deflection was noticed while walking on the deck.

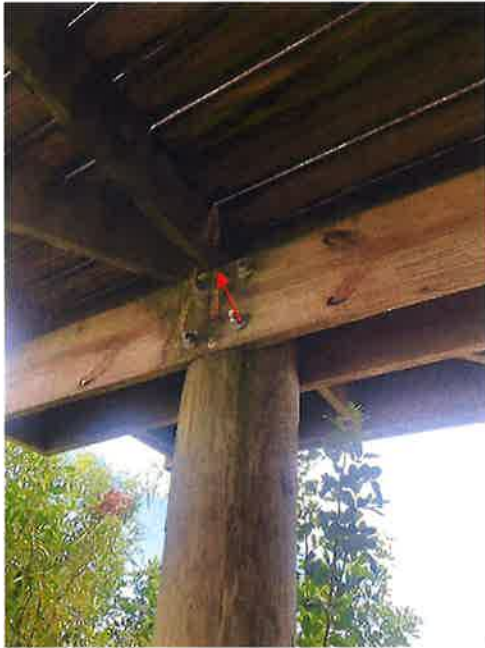
Picture 5

Several hurricane ties and bolts appeared rusted.

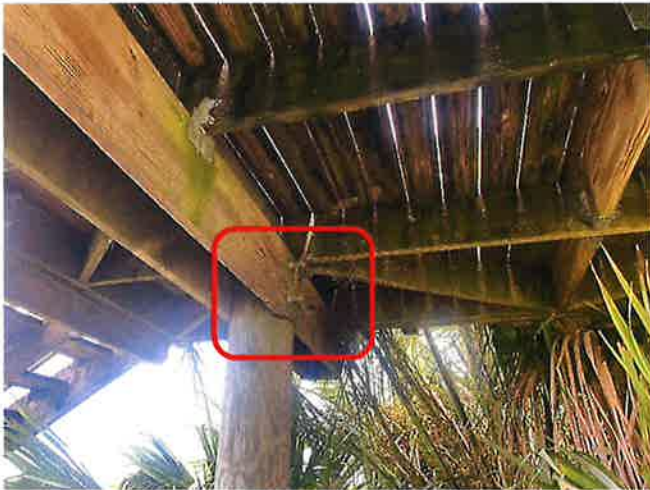
Picture 6

Rusted Simpson hurricane ties in multiple locations.

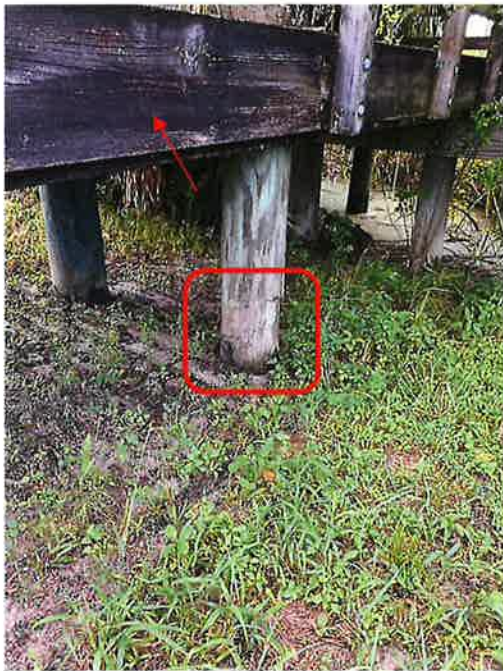
Picture 7

Timber foundation pile surface damage.  
Excessive moisture on primary wood beam.

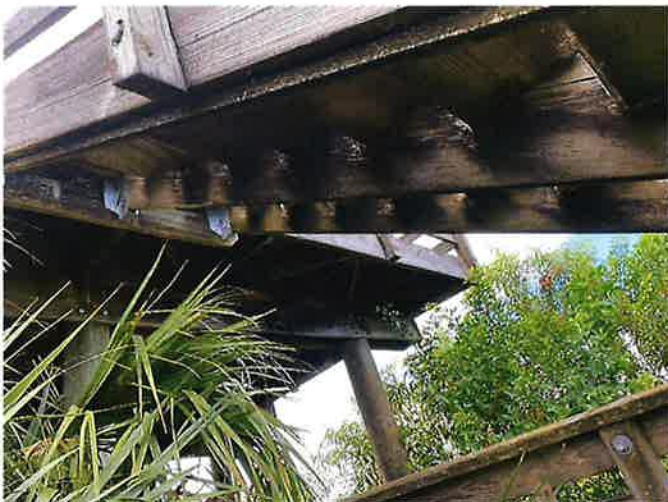
Picture 8

Damaged stair stringers and an excessive deflection  
was noticed while walking on the stairs.

8. Repair/replace wood stairs and stair stringers.

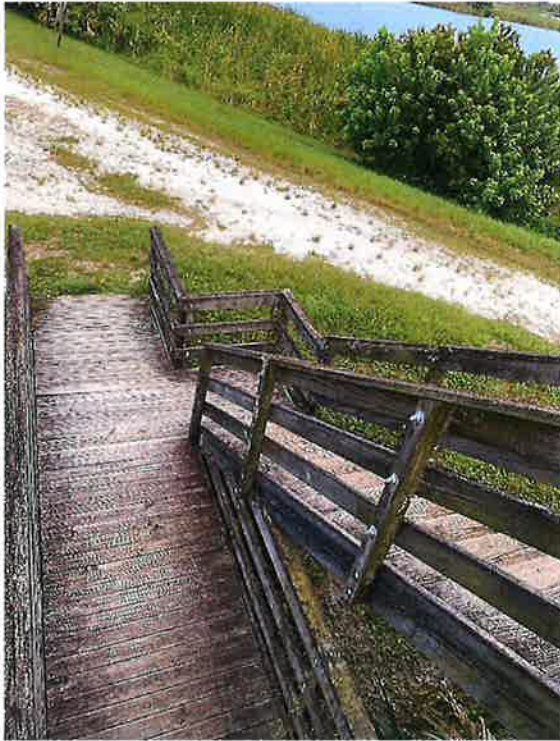
Picture 9

Stairs and deck railing and floor deck planks are in bad condition due to excessive moisture and weather.

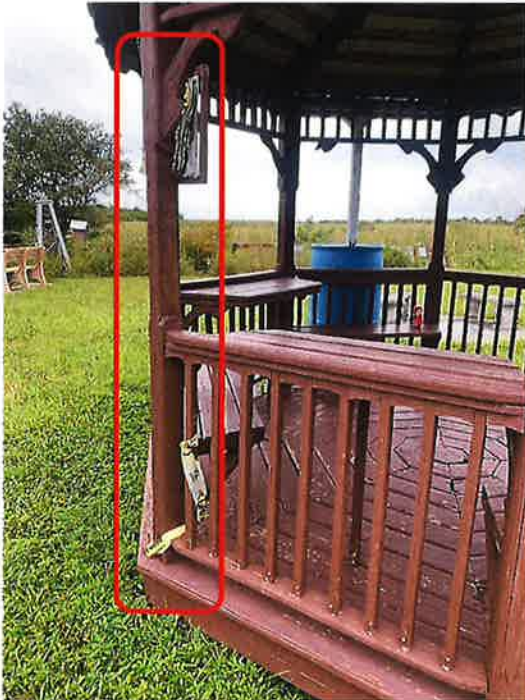
Picture 1

Surface cracks with the possibility of grain shear on wood posts.

The wood railing appeared unstable all around the gazebo, the walkway, and the perimeter area. Wood floor planks appeared damaged and in bad condition due to excessive moisture and weather. Hurricane ties appeared deflected and possibly inadequate in tensional forces. The roof metal seam appeared rusted and the screws rusted. Some floor beams appeared damaged by moisture. Surface damage on the wood posts and possible core cracks. Excessive deck deflection was experienced during the inspection. Grade beams appeared in bad condition, and the connection to the ground is unknown. Structural repairs or gazebo replacement is required in order to continue the operation of the gazebo. Replace the gazebo with a new gazebo is recommended.

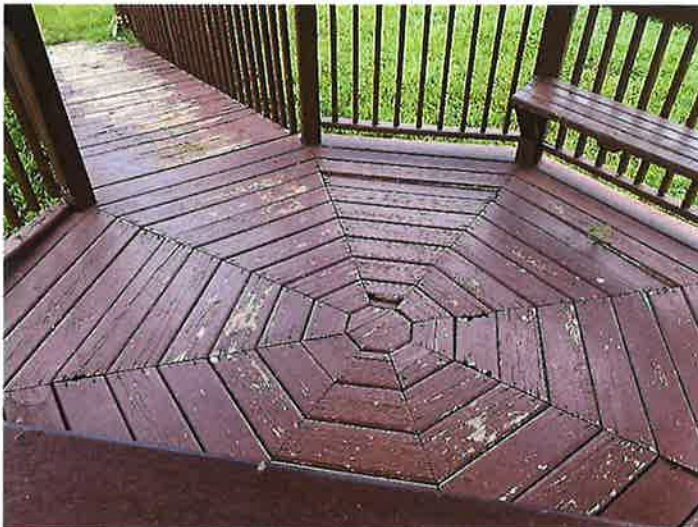
Picture 2

Damaged-cracked wood floor planks. Excessive deflection while walking on the deck.

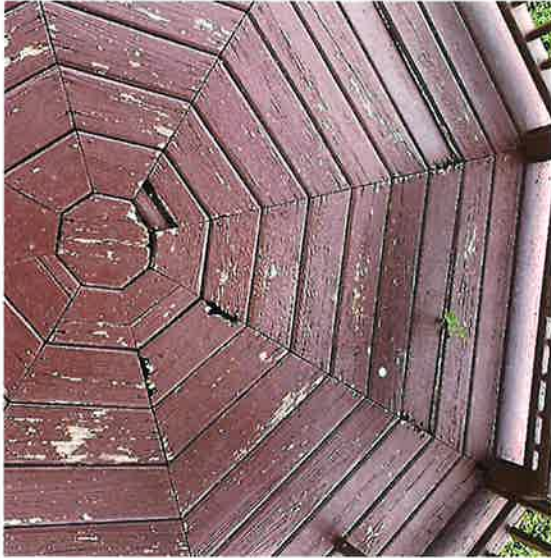
Picture 3

Damaged-cracked wood floor planks.

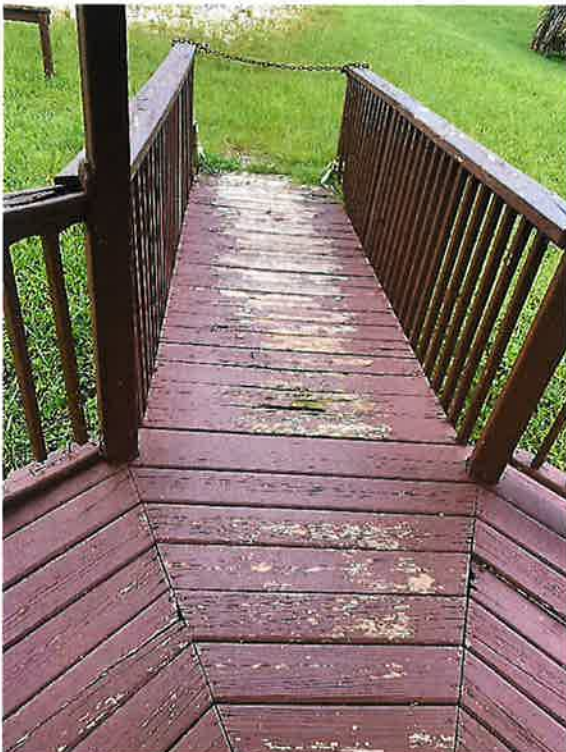
Picture 4

Damaged wood planks on the walkway. An excessive deflection was noticed while walking on the deck.

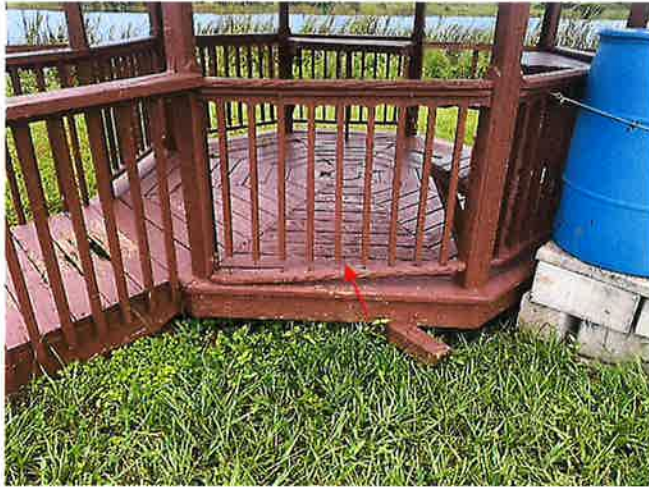
Picture 5  
Damaged railing.

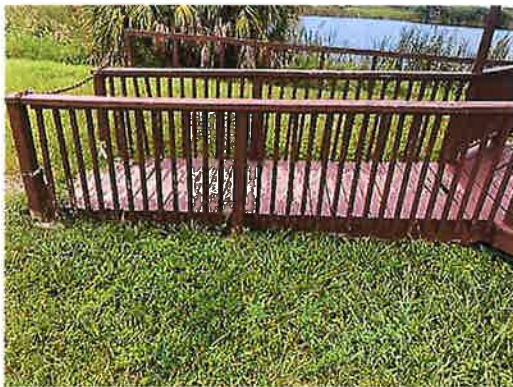
Picture 6  
Damaged walkway railing and walkway beam in bad condition.

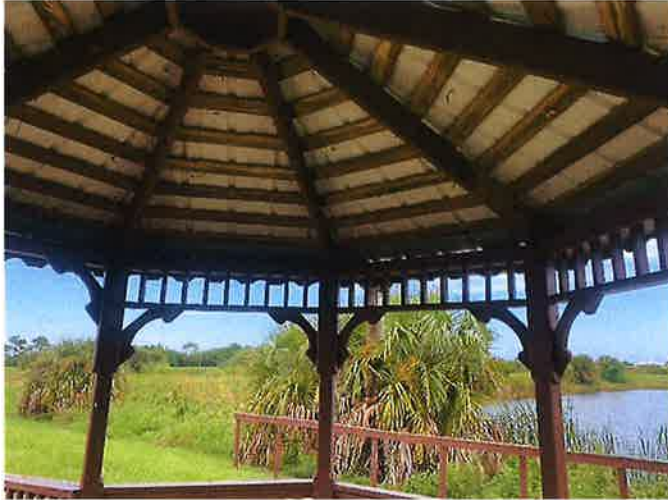
Picture 7

Moisture signs and surface cracks on multiple roof beams and rafters. Screws connecting the metal seam with the rafter appeared rusted and possibly not adequate on uplift forces in an extreme event.

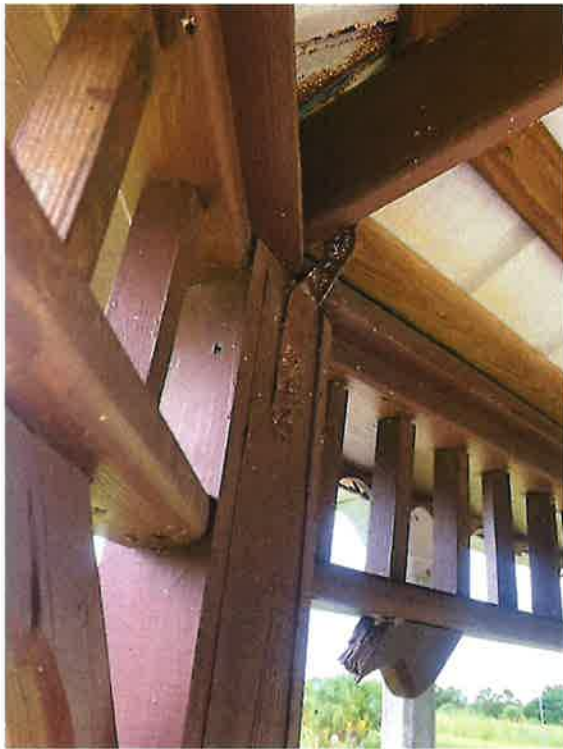
Picture 8

Hurricane ties appeared in bad condition and deflected. Rusted metal seam roof and signs of a water leak.

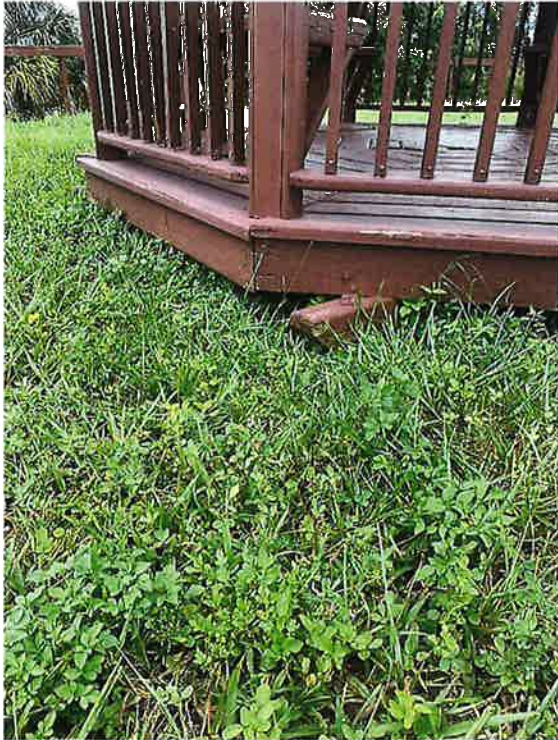
Picture 9

Grade beams and perimeter low beams are in bad condition. Surface cracks and possible further damage due to weather and moisture.

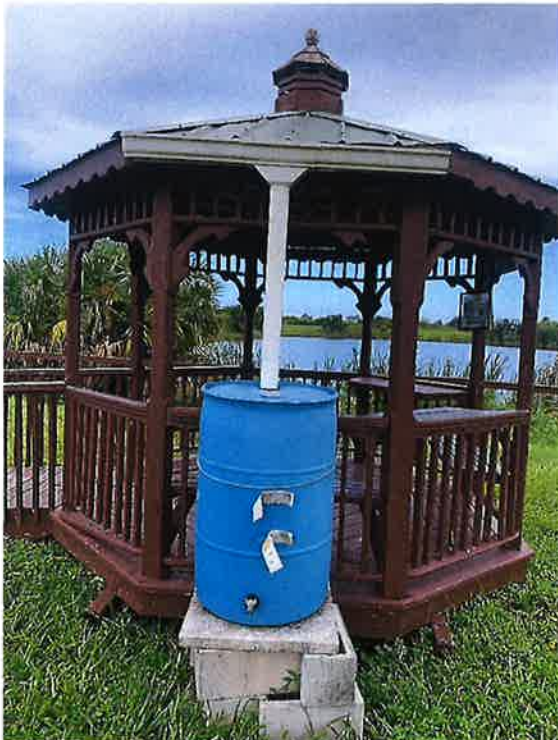
Picture 10

A damaged exterior structure that supports the water barrel.

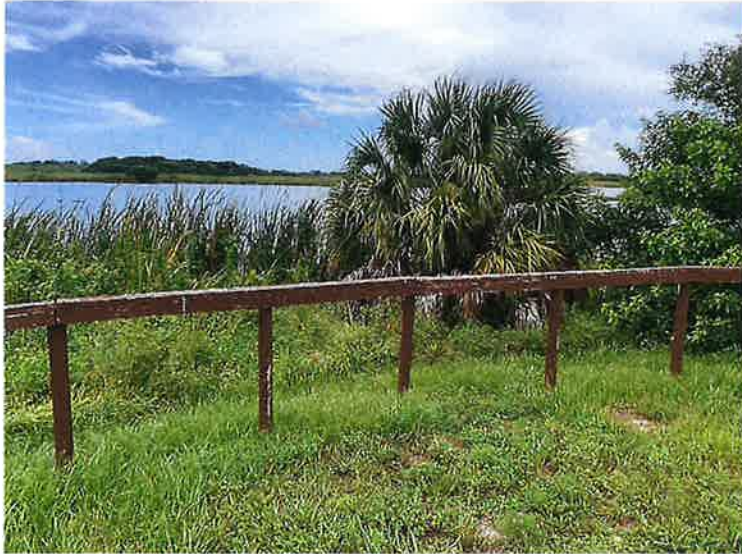
Picture 11

Damaged and unstable perimeter area wood railing.
