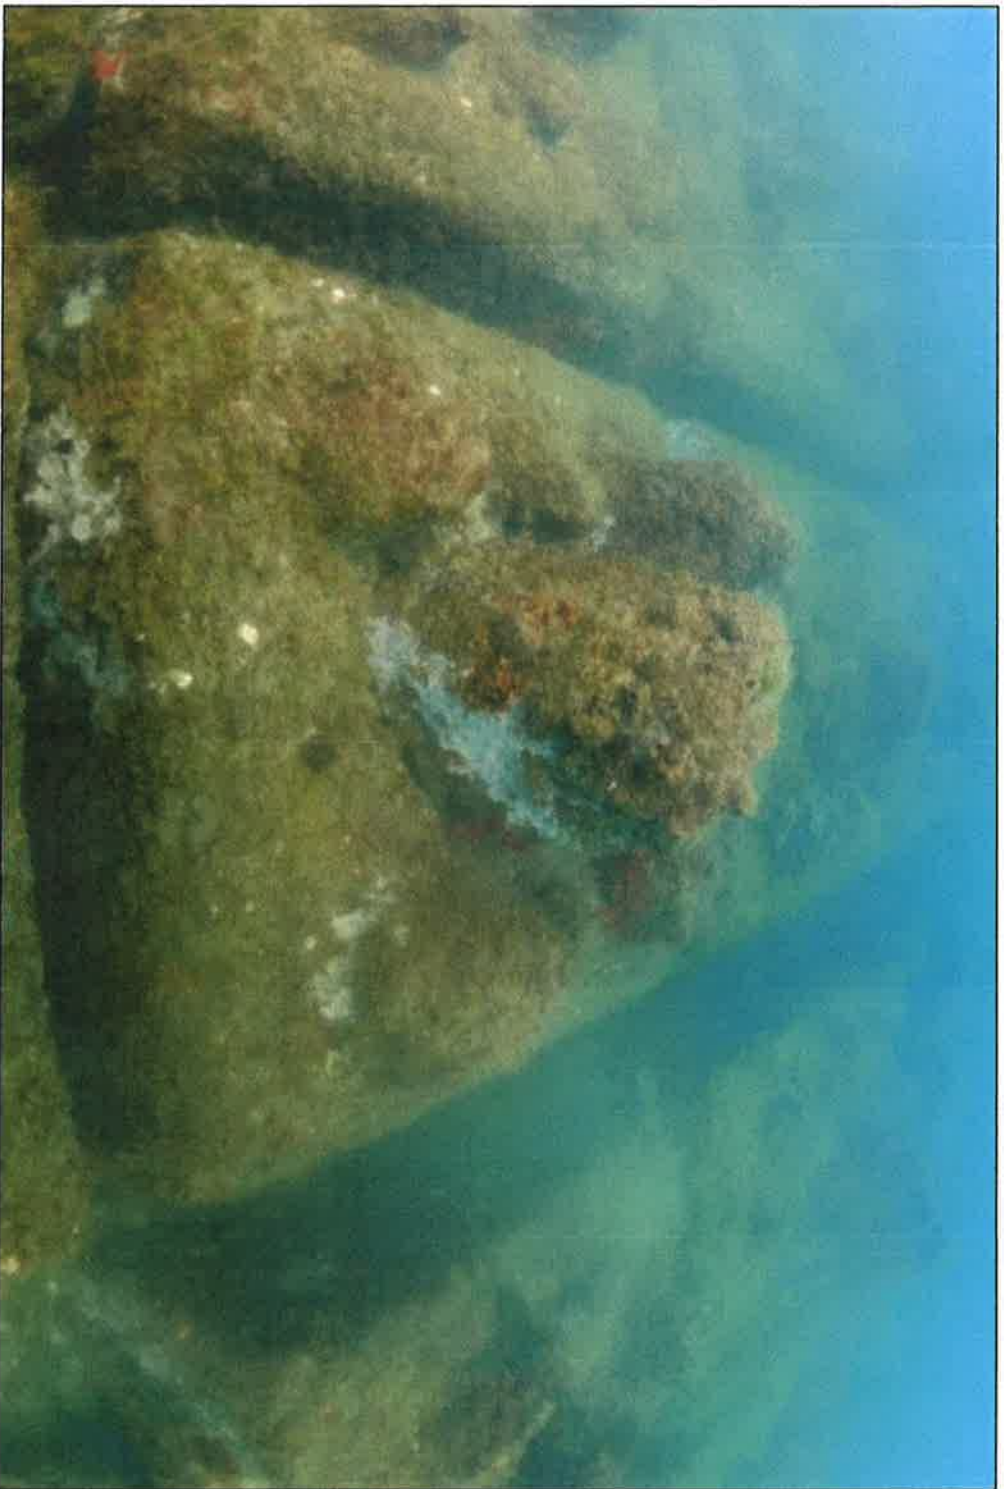
Photo 3. Turf algae, tunicates (*Didemnum* sp.), and bryozoans (*Schizoporella* sp.) encrusting coquina embedded in concrete mats at reef site 7 off the Brevard County Mid Reach shoreline.

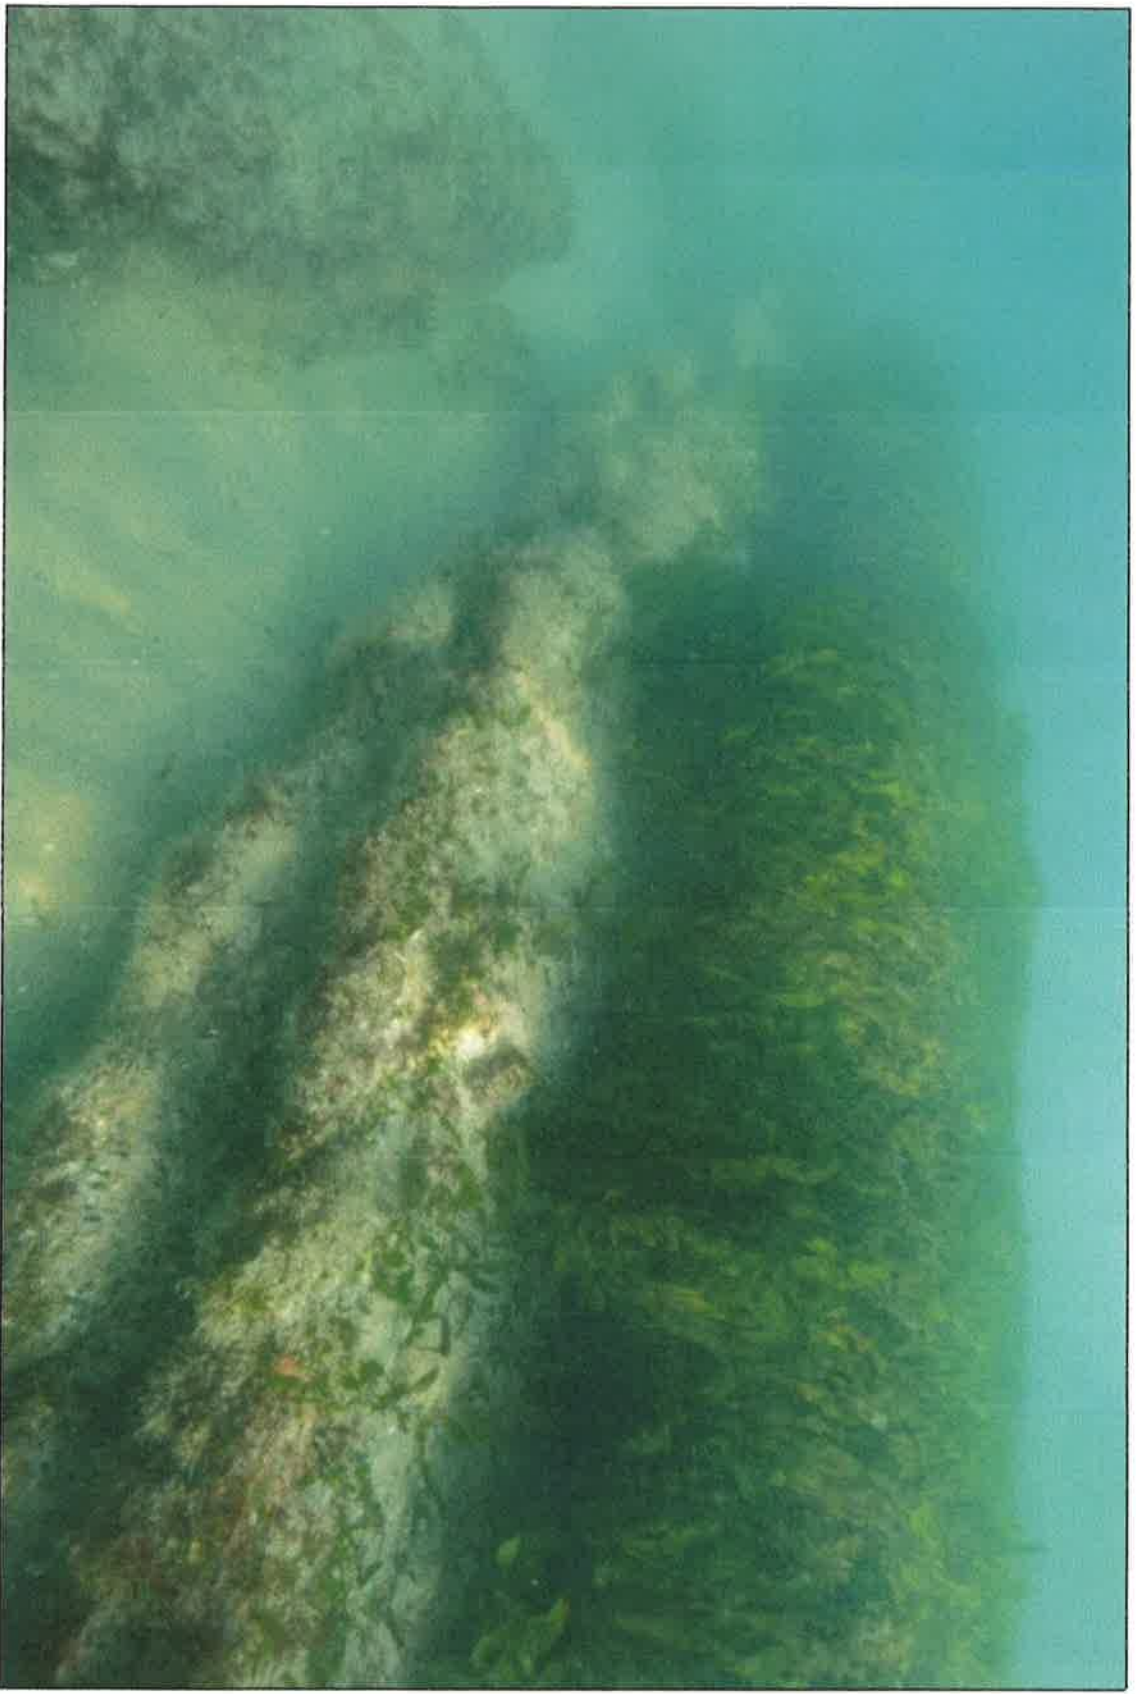
Photo 12. Example of natural hardbottom reef off the Brevard County Mid Reach shoreline showing a dense stand of the green alga *Caulerpa prolifera* in a water depth of approximately 2 m.
