Resolution to adopt the North Merritt Island Hydrologic and Hydraulic Study and Stormwater Model.

North Merritt Island H&H Modeling Study Report

June 2022

North Merritt Island H&H Modeling Study

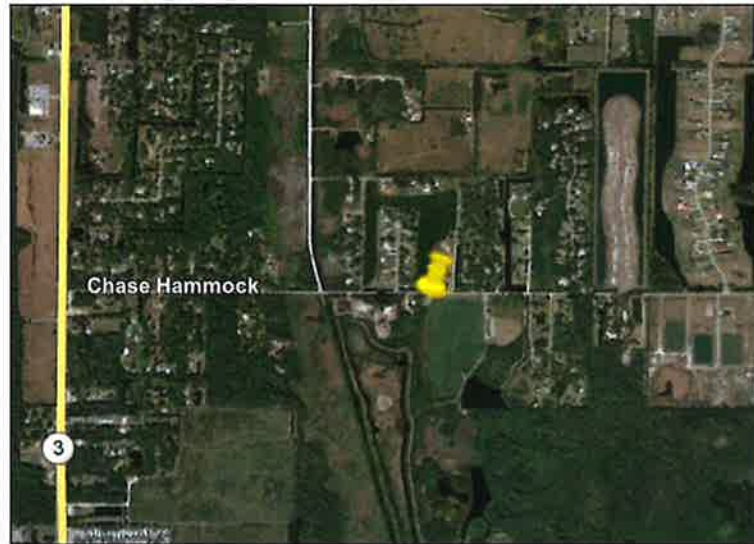
Figure 2.4: SJRWMD Well Location

2.4.1 SJRWMD Gage Data: Gage data was obtained from the SJRWMD Upper Floridan Aquifer Well located at Kings Park in Merritt Island (ID: BR2115). Data was collected for the surficial aquifer (POR 3/12/2009-8/11/2020) and for the upper Floridan (POR 12/4/1985-8/11/2020). See **Figure 2.4**.

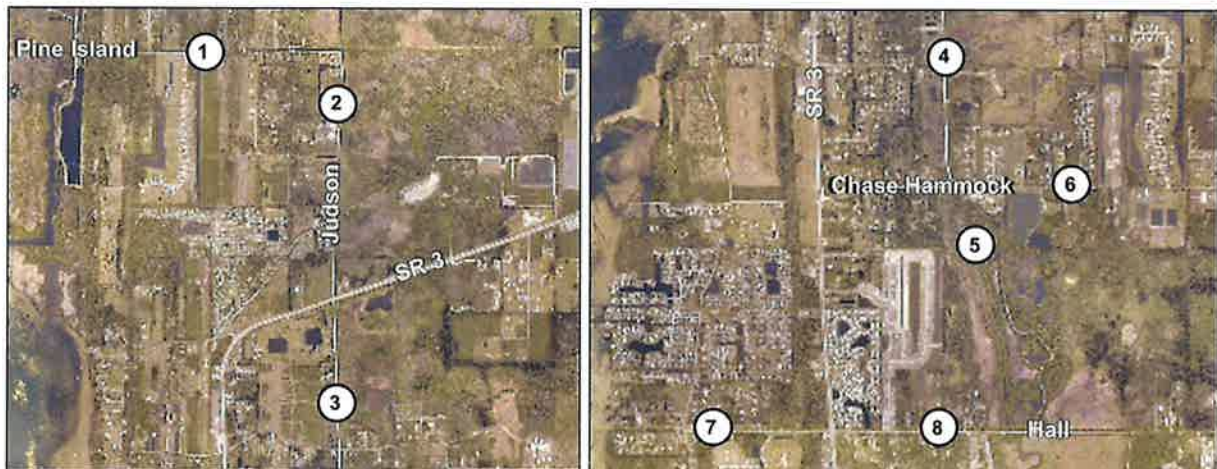
Figure 2.6: Cross Section Survey Locations

The County requested that the SAI Team obtain survey data for several channel systems throughout the watershed that had recently been dredged and/or cleared of vegetation. This included a total of eight (8) channel cross sections throughout the watershed, including ditches along Hall Road, Judson Road, Pine Island Road, and Chase Hammock Road. This work was conducted in August 2020 by Morgan & Eklund, Inc. (M&E). Cross sections provided included both the ground surface and bottom of muck elevations at each cross section. **Figure 2.6** on the following page shows the location of the 8 cross sections. The survey data is included in the electronic deliverable accompanying this report.

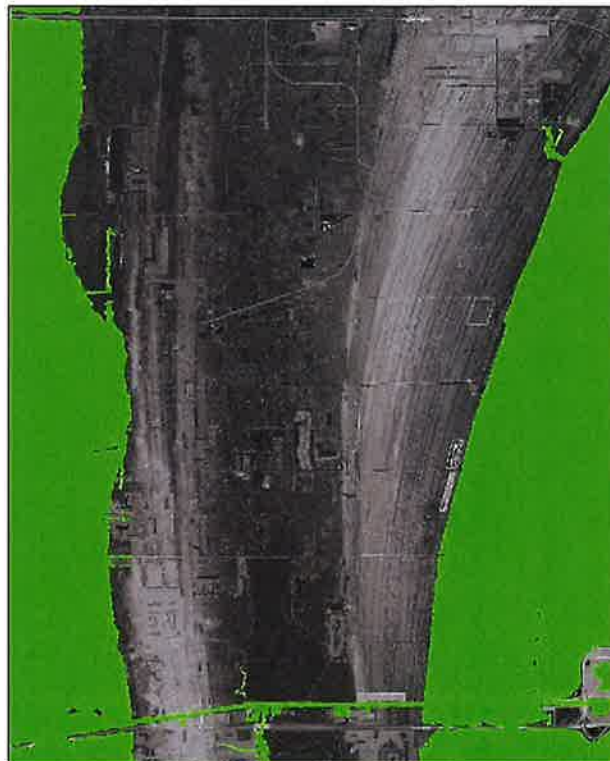
Figure 3.1: Missing Topographic Information

Boundary Waterbodies: The original DEM surface provided by the County did not include any topographic information for the Indian River Lagoon, Banana River Lagoon, Canaveral Barge Canal, and several channel features directly connected to these waterbodies. **Figure 3.1** depicts the areas missing topographic information, shown in green.

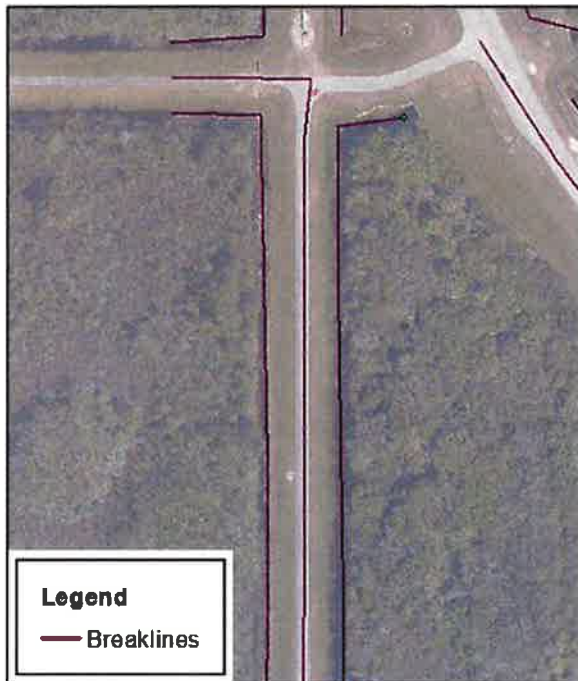
Figure 3.10: Roadway Breaklines

- **Roadways** – Breaklines were placed at along the centerline of roadways and along the adjacent swales (See **Figure 3.10**). In some cases, control volumes were drawn along the centerline and breaklines were limited to the roadway swales.
- **Ditches/Channels** – Breaklines were placed along the centerline of minor swales and ditches that were not modeled with a 1D channel link to provide conveyance within the 2D overland portion of the watershed (See **Figure 3.11**).
- **Within Ponds and Wetlands** – Breaklines were drawn within stormwater ponds and large wetland areas to ensure the groundwater mesh was aligned with the surface water mesh for groundwater-surface water interaction within the waterbodies (See **Figure 3.12**).

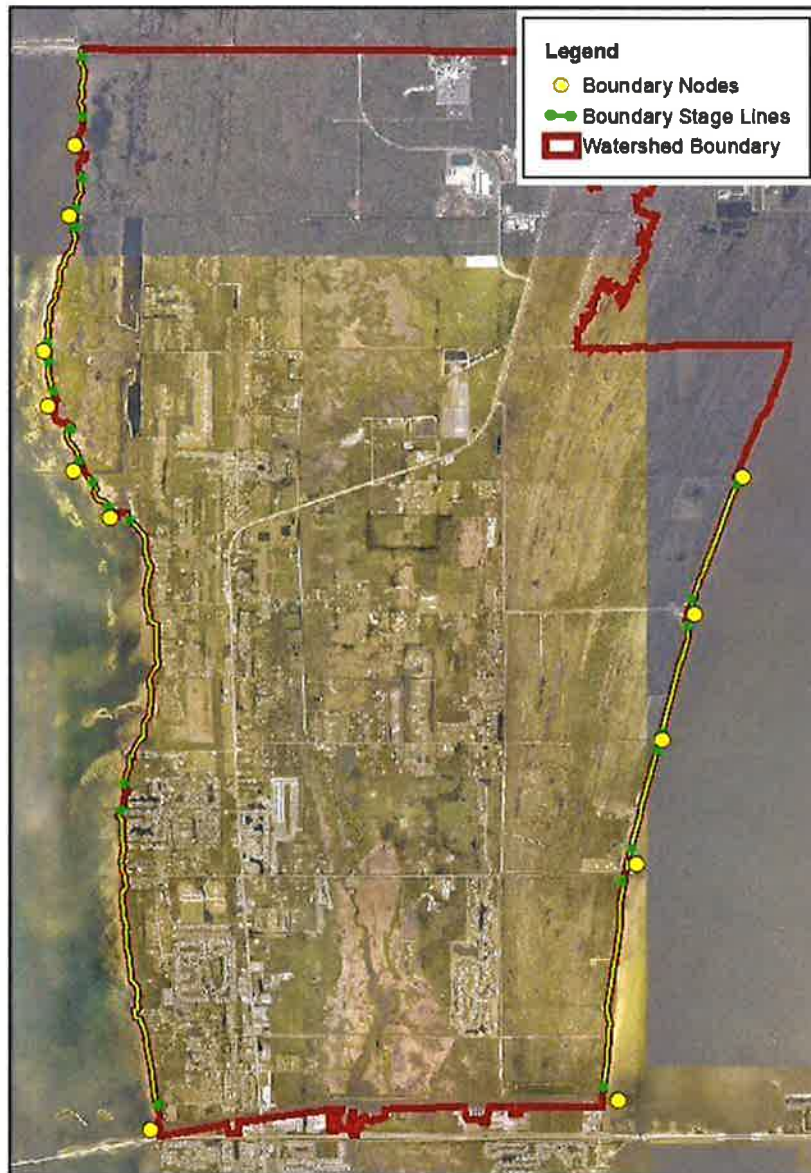
Figure 3.20: Boundary Node and Line Locations

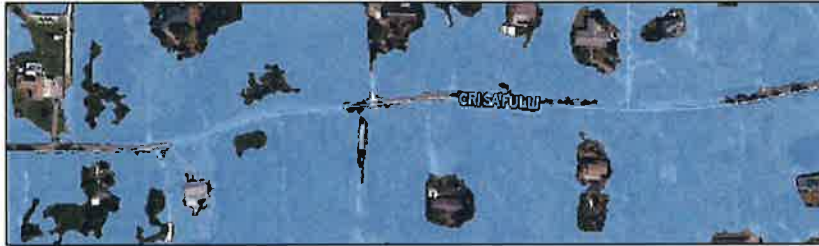
Figure 8.1: 10-Year, 24-hr Floodplain along E. Crisafulli Rd.

Design Storm Simulations: The floodplains for the NMI watershed depict significant inundation for most simulated storm events, particularly in the low-lying central wetland areas of the watershed. This includes the Sykes Cree/ mosquito impoundment area north towards East Crisafulli Road. Roadway flooding is shown along several collector roads during the 10-year storm event, including East Crisafulli Road (**Figure 8.1**) and West Crisafulli Road (**Figure 8.2**).

Both locations above, along with other areas such as East Hall Road below (**Figure 8.3**), are expected to experience significant inundation of low-lying yards and driveways during the 10-year event.

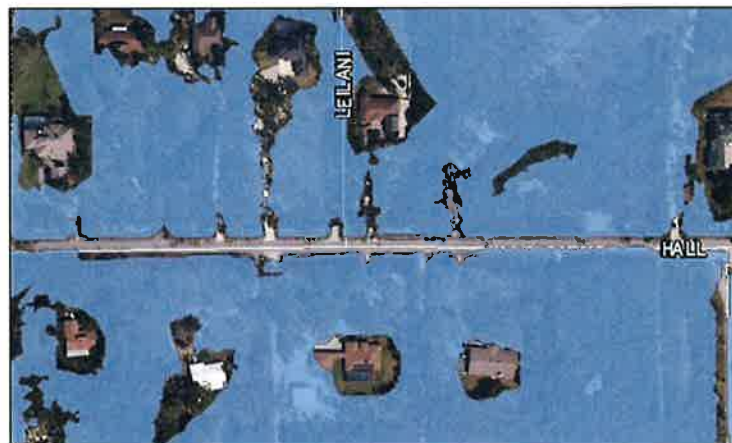
Figure 8.3: 10-Year, 24-hr Floodplain along E. Hall Rd.

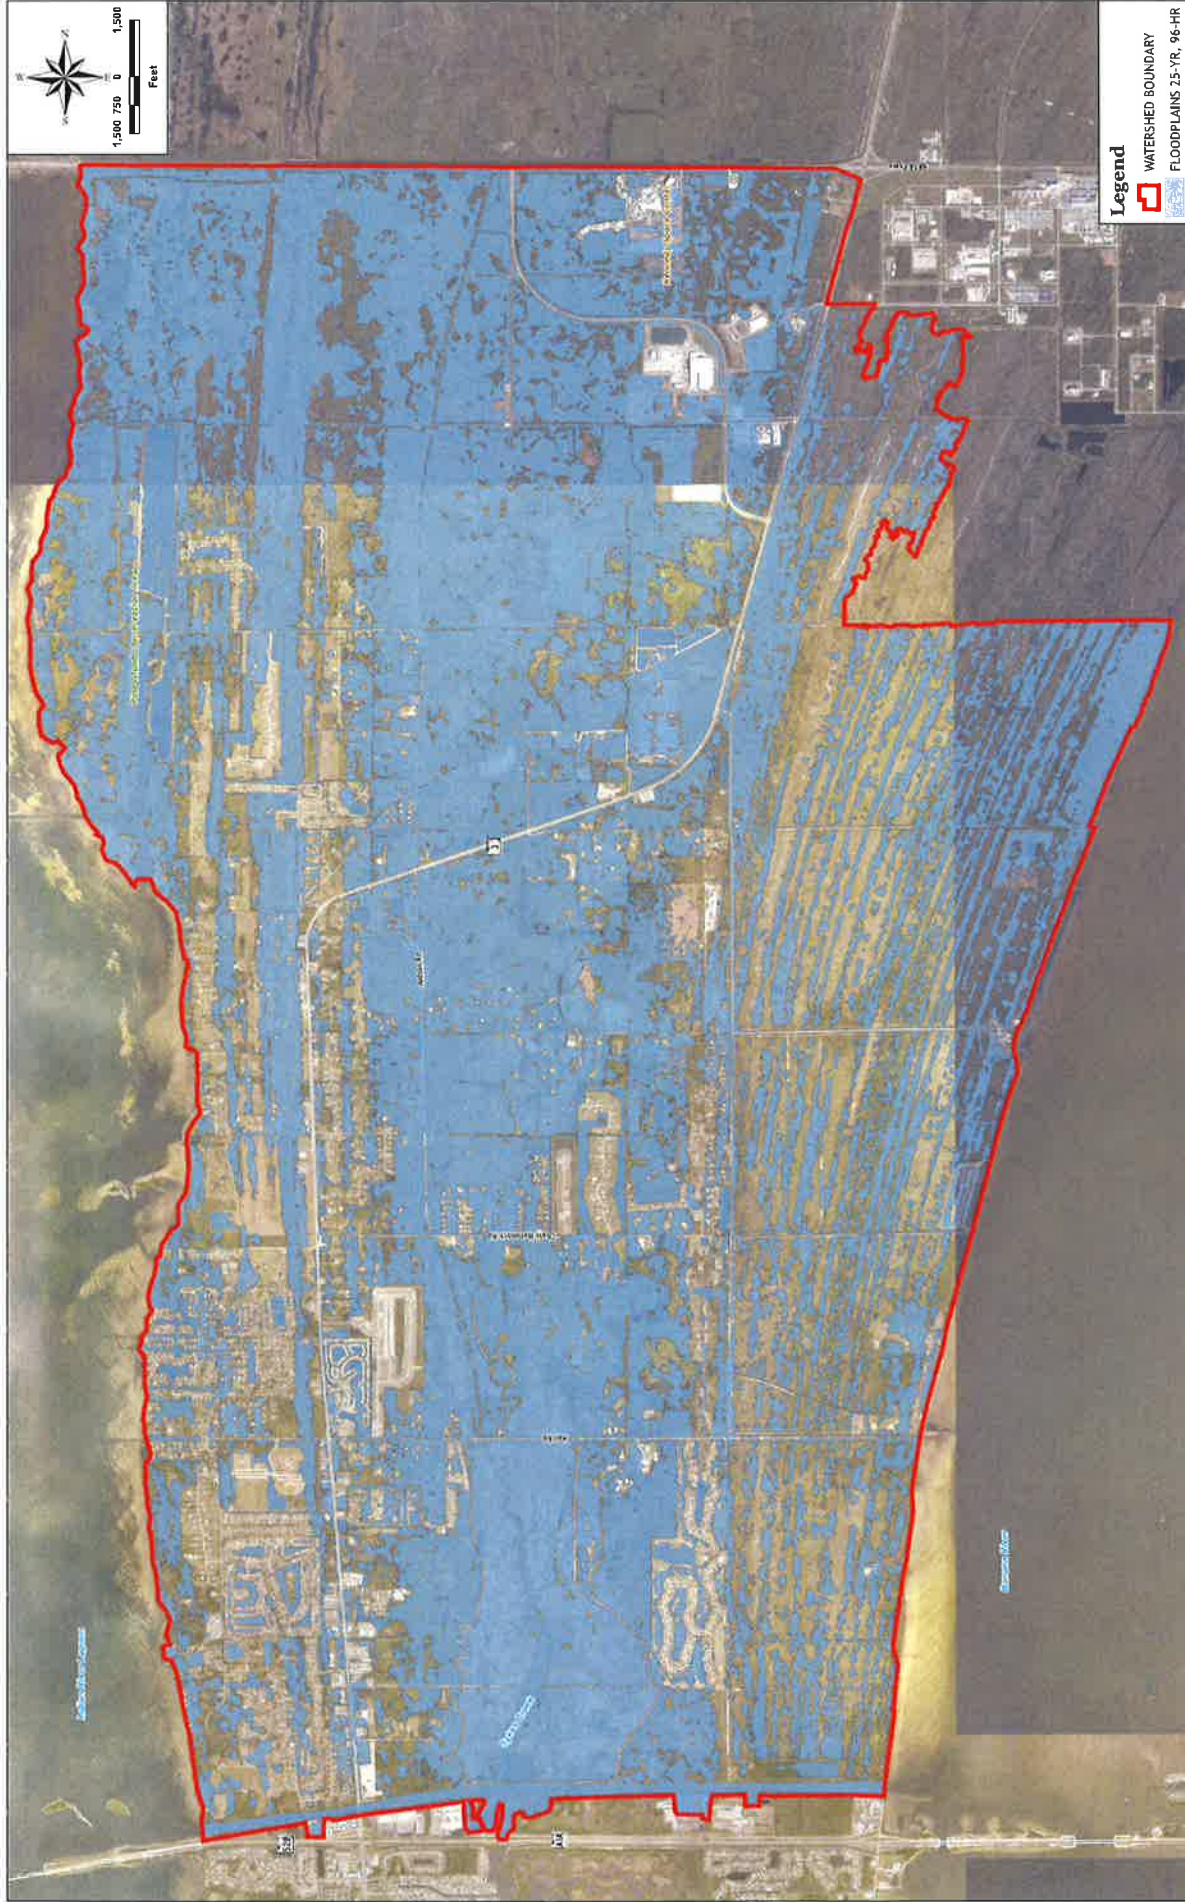
SINGHOFEN & ASSOCIATES, INC. STORMWATER MANAGEMENT AND CIVIL ENGINEERING	BREVARD COUNTY NATURAL RESOURCES MANAGEMENT DEPARTMENT	NORTH MERRITT ISLAND H&H MODELING STUDY	EXISTING CONDITIONS FLOODPLAINS 25-YEAR, 96-HOUR	EXHIBIT 6
--	---	--	---	----------------------

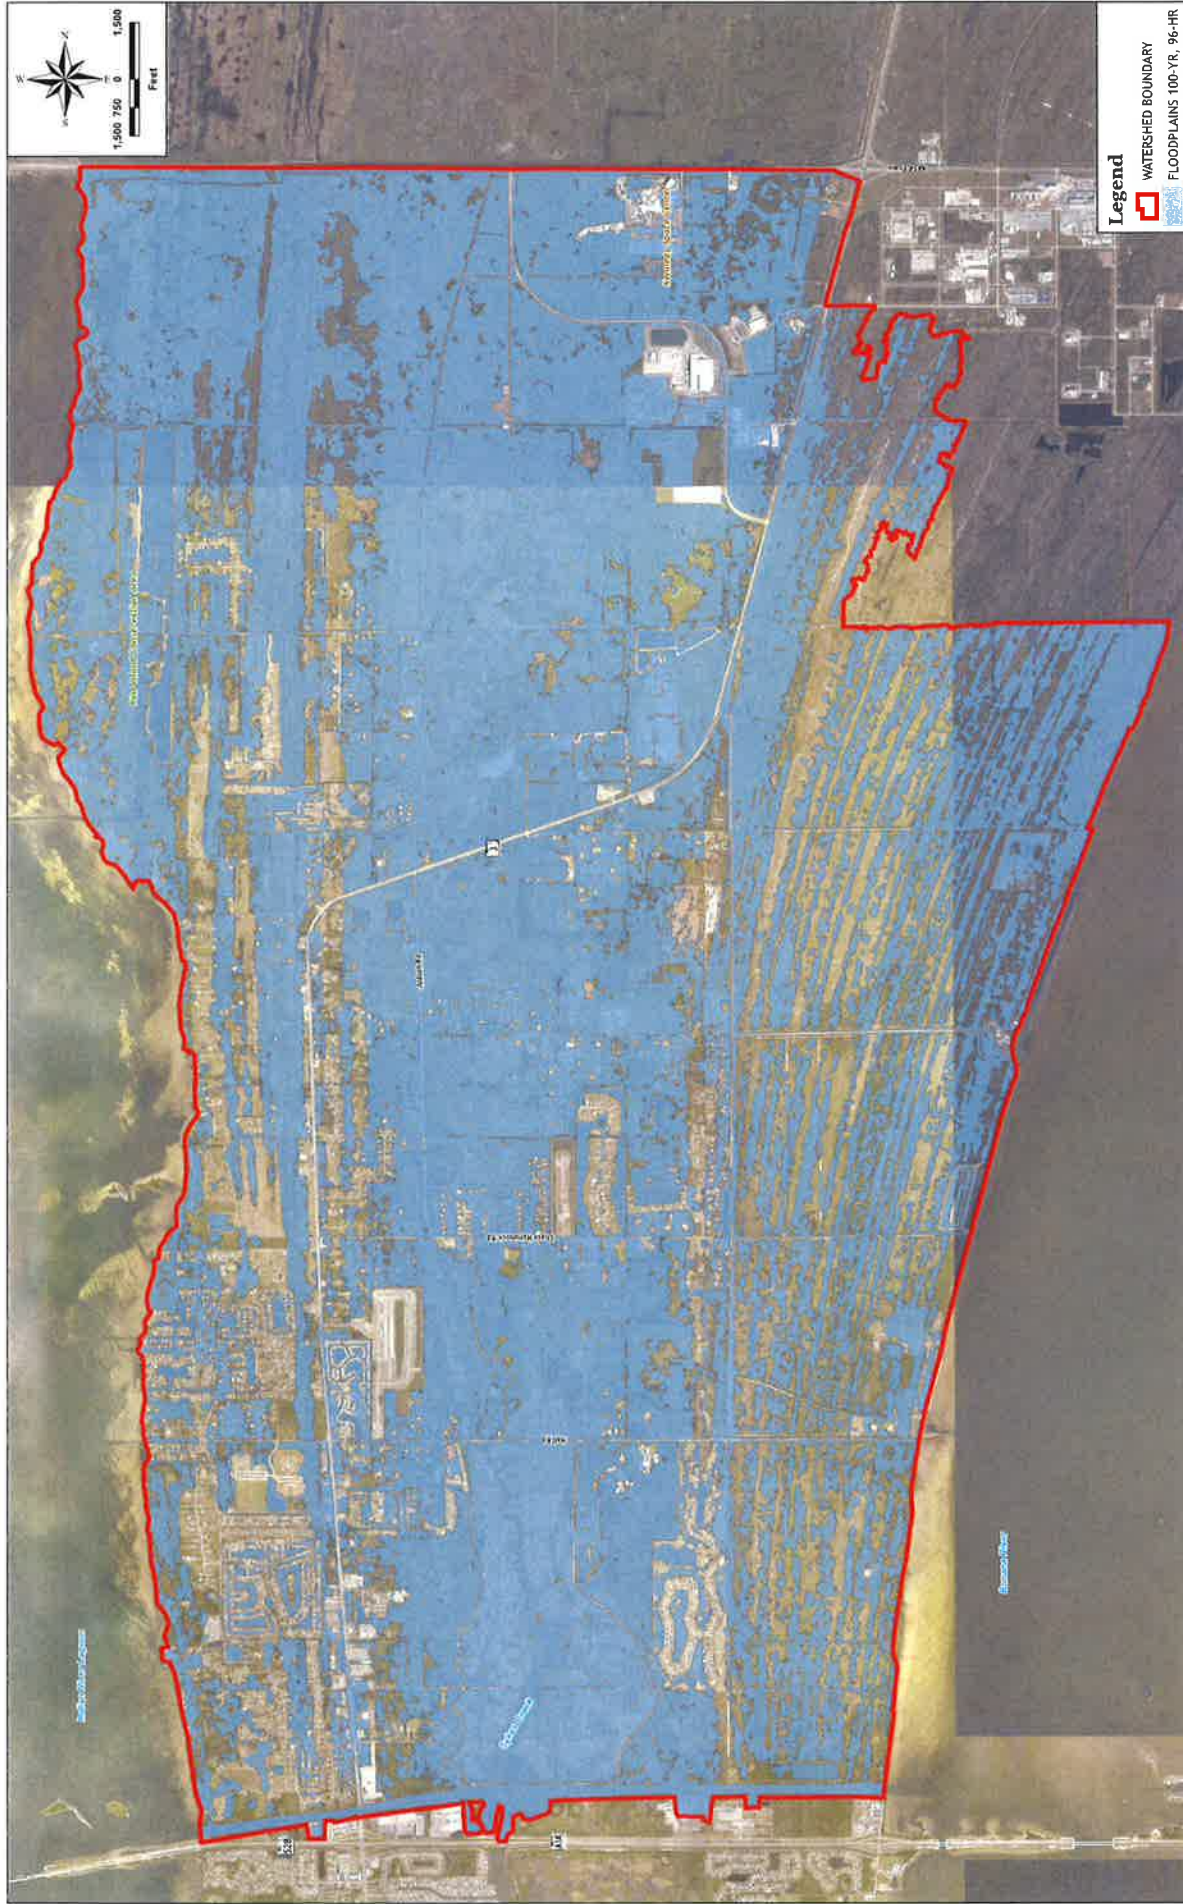
SINGHOFEN & ASSOCIATES, INC. STORMWATER MANAGEMENT AND CIVIL ENGINEERING	BREVARD COUNTY NATURAL RESOURCES MANAGEMENT DEPARTMENT	NORTH MERRITT ISLAND H&H MODELING STUDY	EXISTING CONDITIONS FLOODPLAINS 100-YEAR, 96-HOUR EXHIBIT 7
--	---	--	--

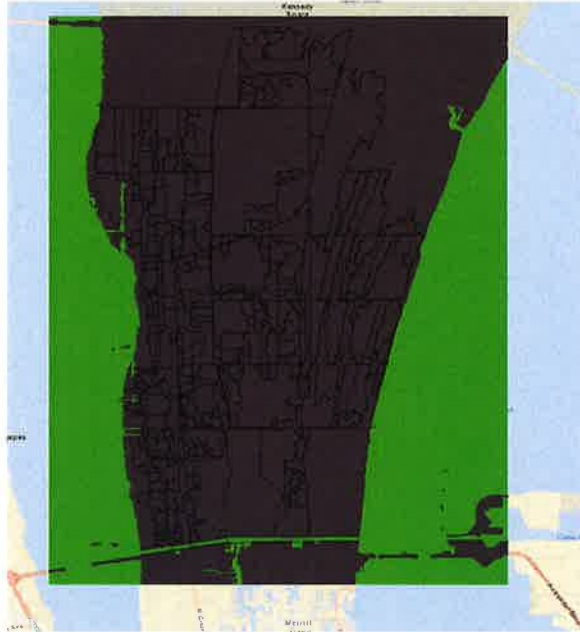
1. Identify the Extent of the DEM update
 - Indian River Lagoon, Banana River, and Canaveral Barge Canal portions of the DEM, this extent represented the area in green in the figure below, which include portions of the 2007 DEM identified as NULL.

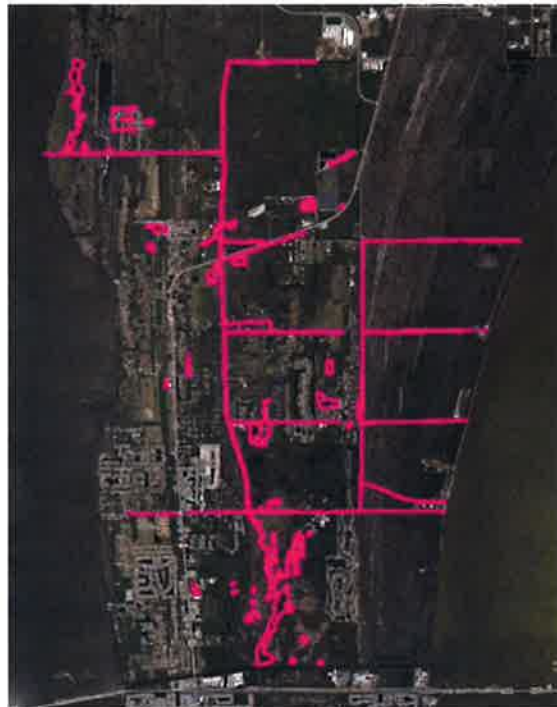
- For interior portions of the DEM, the update extent included modeled channels and naturally ponded areas identified from the DEM. Update extent is shown in pink in the image below.

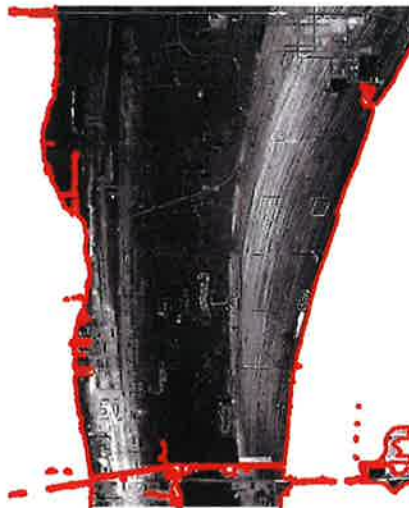
2. Generate a 3D line at the boundary to tie the updated area into the existing topography.
 - The figure below shows the extent of the 3D line extracting elevations from the existing DEM. A similar data was generated for the interior area.

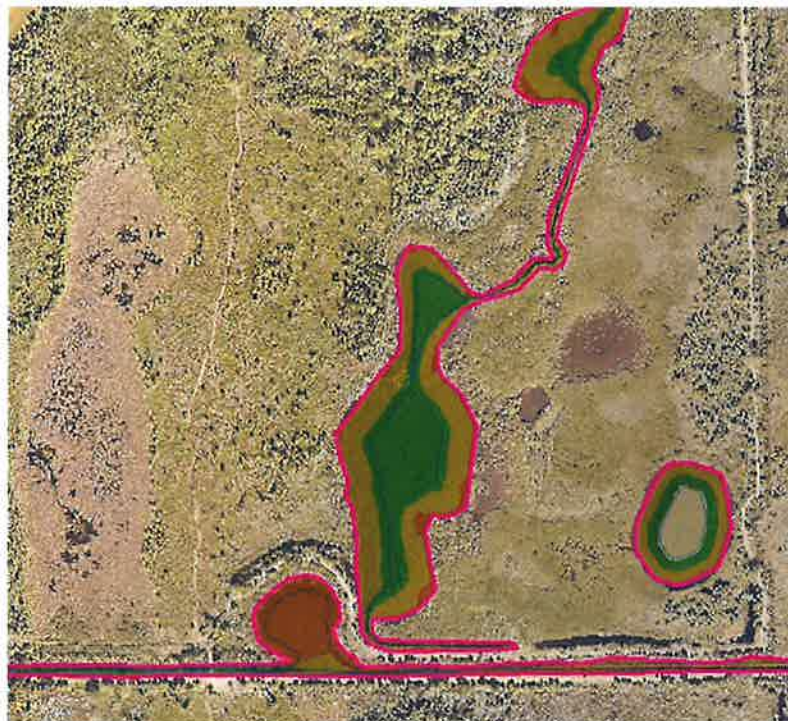
- Interior DEM ponding areas updated based upon the DEM extent of open water and aerial imagery to estimate the extent and depth of water. For the majority of areas a depth of -3.0 feet NAVD88 was used to approximate the open water portion. This depth is consistent with canals and provides sufficient connection for the groundwater model to interact with the surface water model. The interconnected lakes west of the Pine Island Stormwater Facility a depth of -5.0 feet was used based upon channel inverts in the model imagery. The resulting depth DEM was then used to "push down" the DEM an elevation of zero at the edge down to the approximated depths in the middle. The figure below shows a portion of the DEM update extent and resulting update.

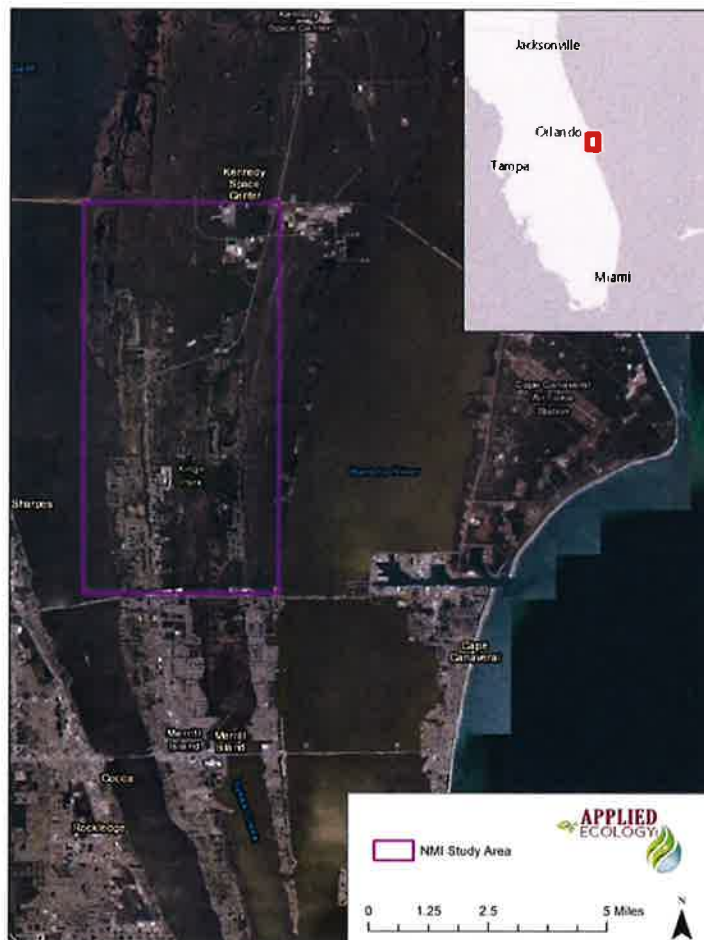
Figure 1 – Location of the North Merritt Island study area

This project focused on the North Merritt Island (NMI) watershed of between the NASA Parkway and Highway US-A1A (Figure 1). The NMI area is characterized by two north-south ridges with the Sykes Creek between draining into the east-west running Barge Canal. It is bordered by the Indian River Lagoon to the west and the Banana River to the east. There are clusters of agricultural and residential land cover on the ridges with scrub and wetland between, intercut with drainage ditches and canals.

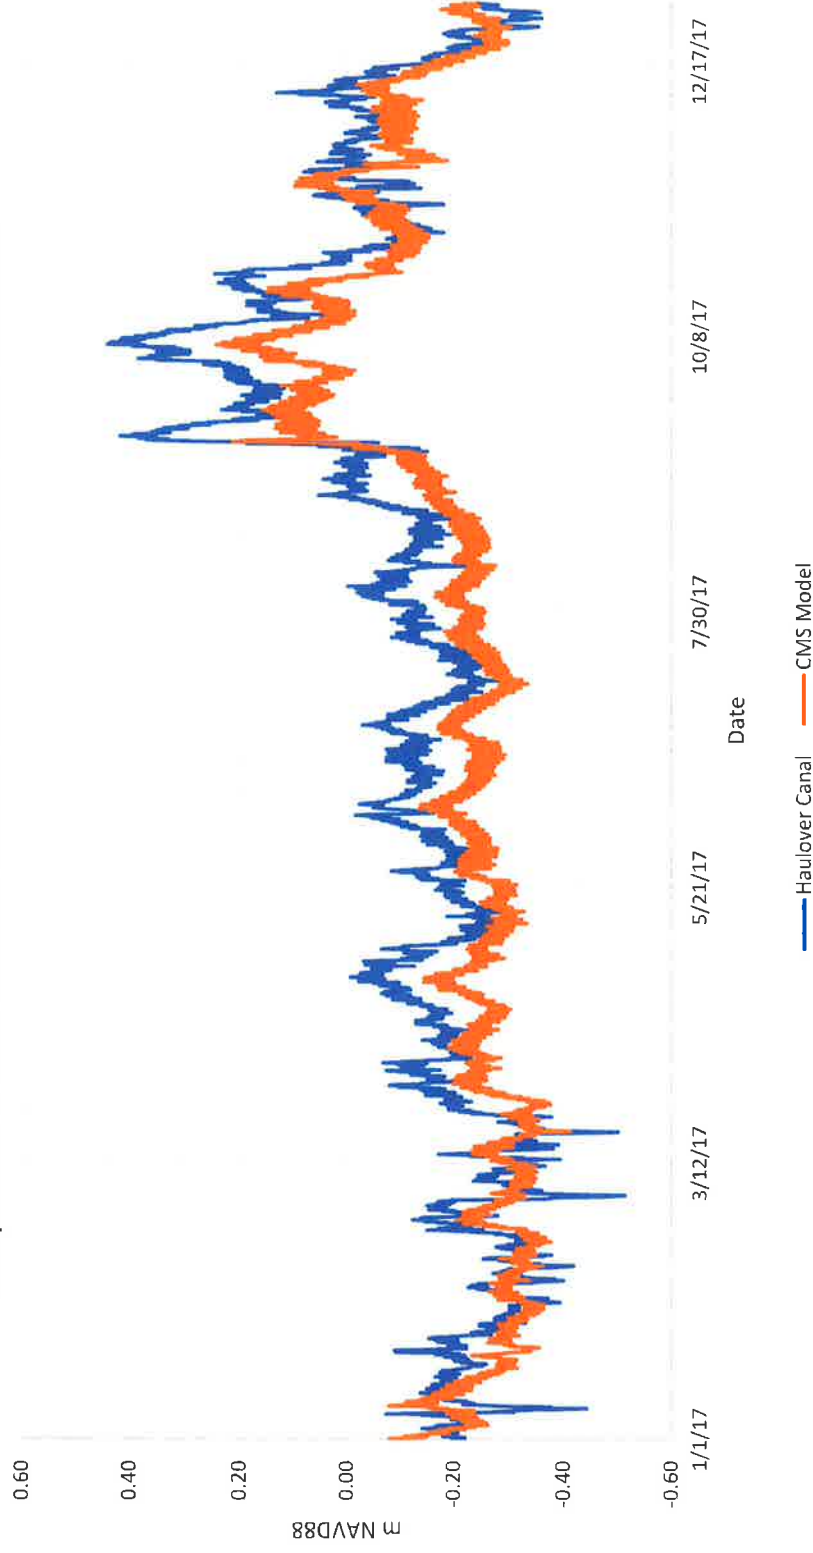
Figure 14 - Comparison of 2017 measured and model water level data at Haulover Canal. R-value is 0.91 and R2 value is 0.84.

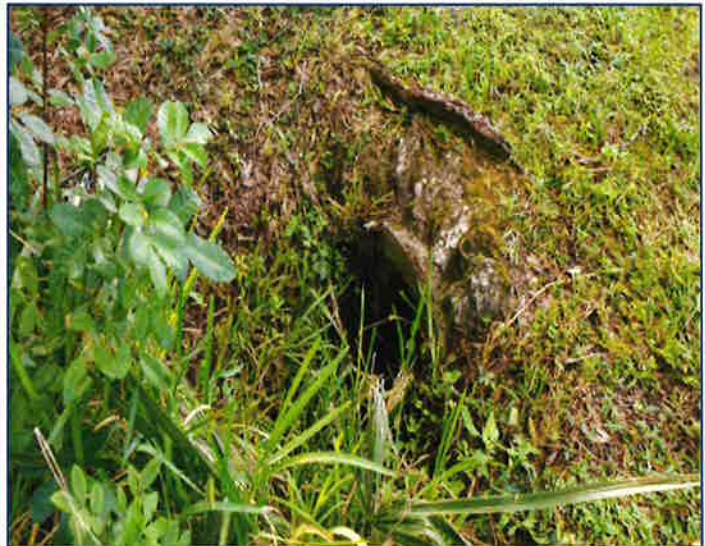
Field Photo

Field Visit Notes: Upstream end of culvert partially silted. Tideflex pipe end treatment. Tideflex product does not appear to be function optimally, the rubber appears still from oxidation. It is recommended that the manufacturer provide an opinion as to how well the structure will function in this condition.

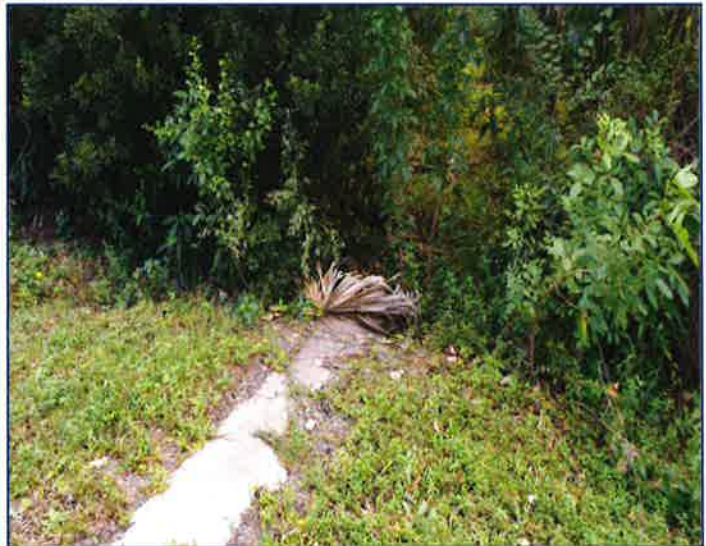
Field Photo

Field Visit Notes: Upstream end of culvert partially silted. Tideflex pipe end treatment. Tideflex product does not appear to be function optimally, the rubber appears still from oxidation. It is recommended that the manufacturer provide an opinion as to how well the structure will function in this condition.

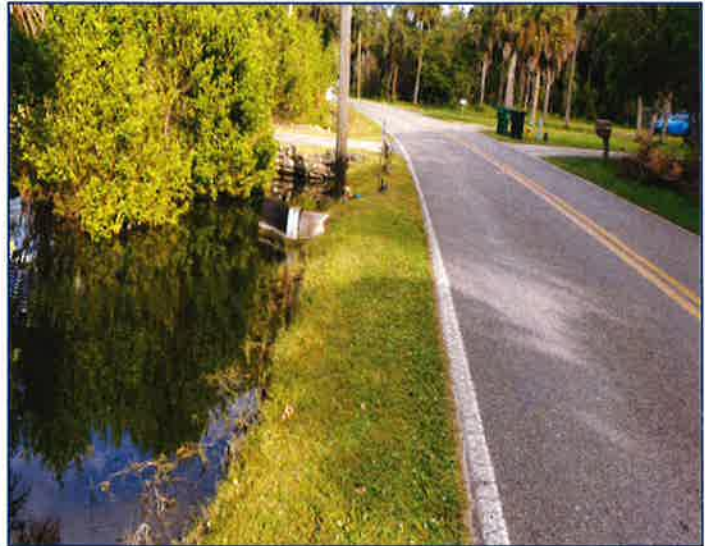
Field Photo

Field Visit Notes: Tideflex pipe end treatment. Tideflex product does not appear to be function optimally, the rubber appears still from oxidation. It is recommended that the manufacturer provide an opinion as to how well the structure will function in this condition.

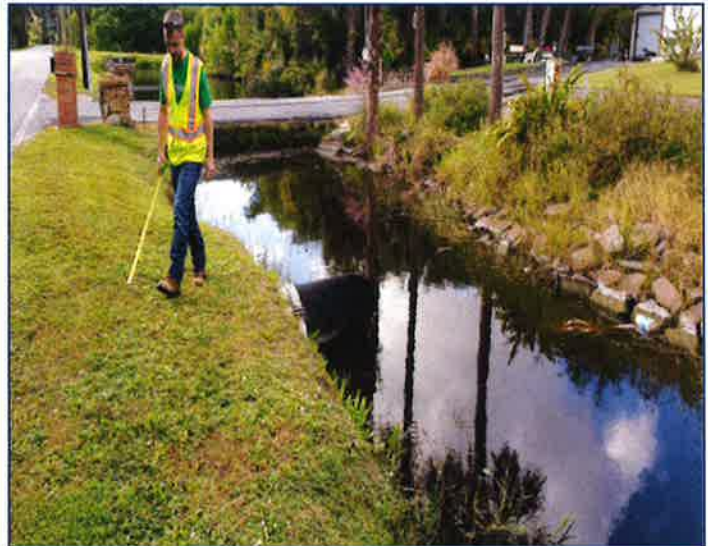
Field Photo

Field Visit Notes: Tideflex pipe end treatment. Tideflex product does not appear to be function optimally, the rubber appears still from oxidation. It is recommended that the manufacturer provide an opinion as to how well the structure will function in this condition.

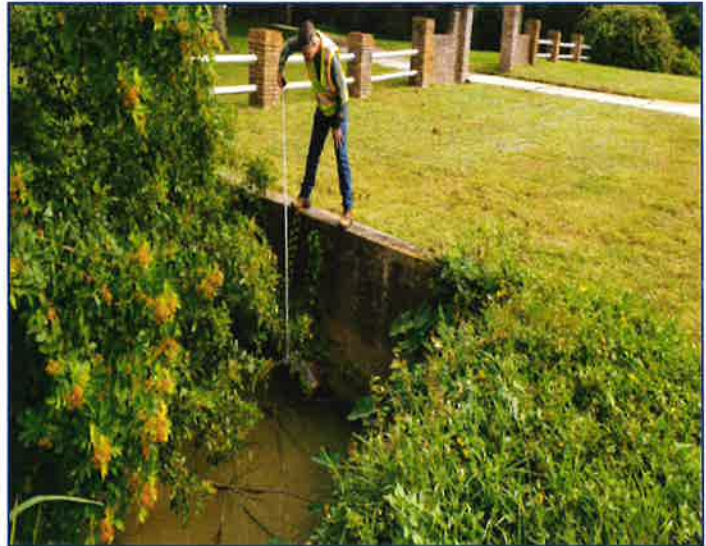
Field Photo

Field Visit Notes: As water flows north across Grant Road this link represents the controlling (first) culvert in a series of culverts that conveys water to the west. This culvert under a driveway at 210 Grant Rd is rusted and the channel is overgrown

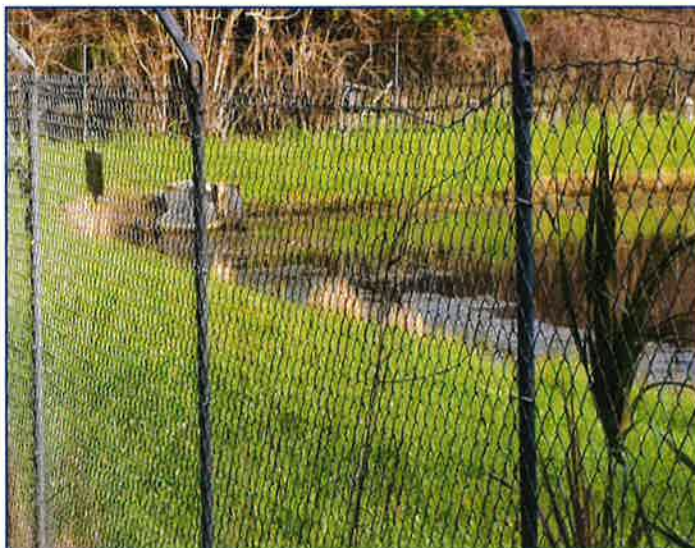
Field Photo

Field Visit Notes: FDOT pond 133 (ph 321-634-6100). SWAMP has elevations missing top dimension and orifice dimension. Field estimated as a Type C structure with a 3 inch orifice

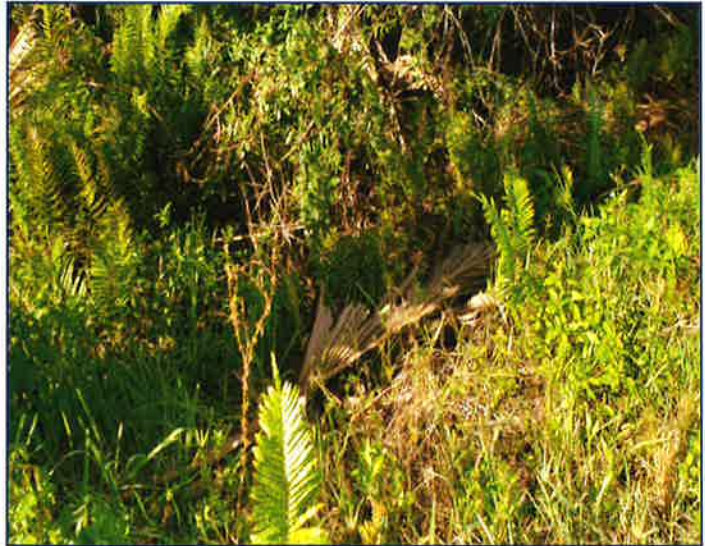
Field Photo

Field Visit Notes: Culvert is in SWAMP, but no evidence of the culvert was found in the field. It is likely that the culvert has been silted for many years and no longer functions as the primary outlet for this area. Maintenance to restore functionality of structure.

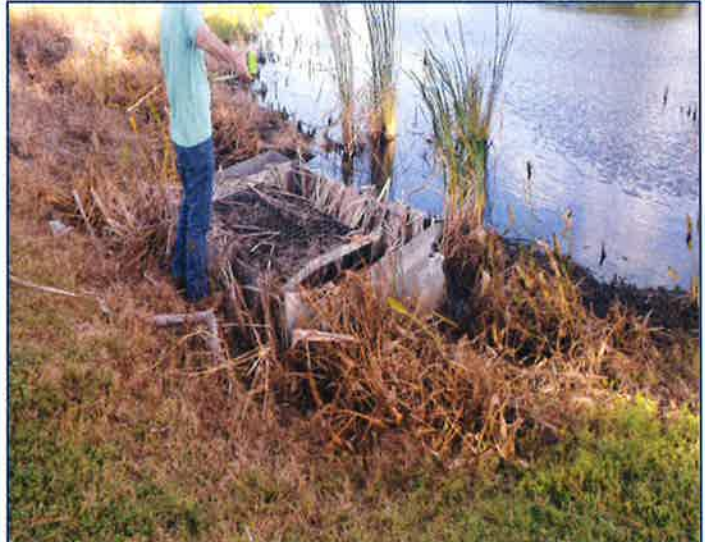
Field Photo

Field Visit Notes: The SWAMP database has structure elevations without specified dimensions. Dimensions collected in the field to incorporate into the model include: top 54x37; 3 slots 1 and 2 are 36x11.5 and 3 is 54x12.5. orifice is 3". Noted that the Skimmer was damaged and in need of repair or replacement.

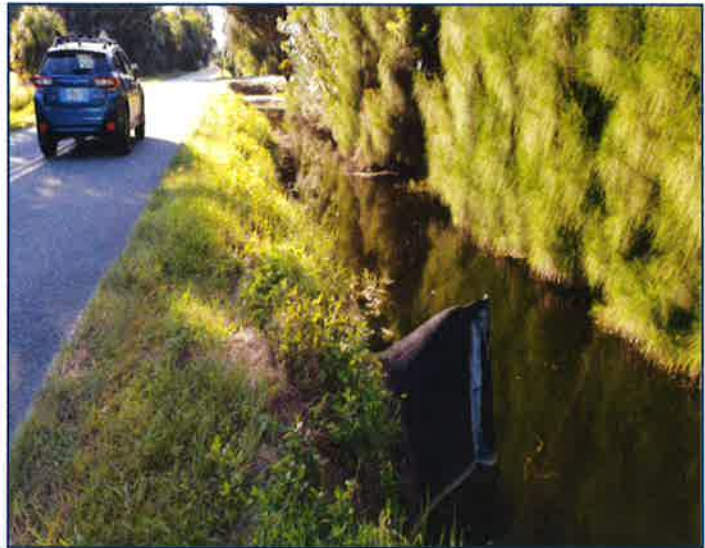
Field Photo

Field Visit Notes: Tideflex pipe end treatment. Tideflex product does not appear to be function optimally, the rubber appears still from oxidation. It is recommended that the manufacturer provide an opinion as to how well the structure will function in this condition.

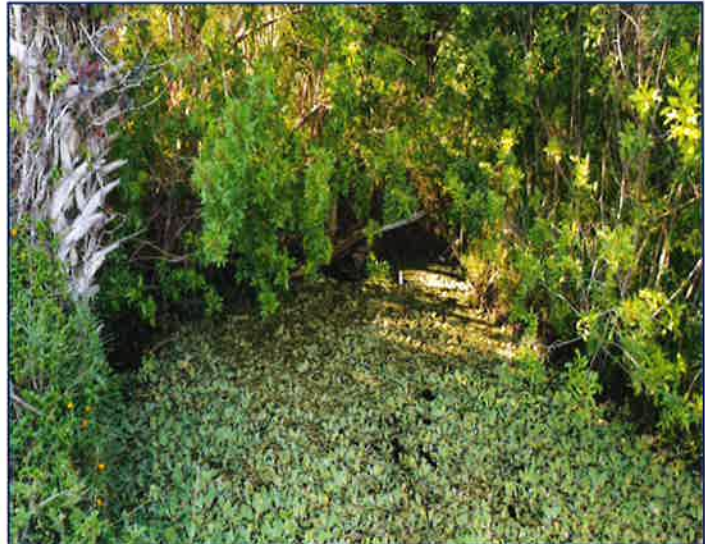
Field Photo

Field Visit Notes: Tideflex pipe end treatment, submerged at current water level. Tideflex product does not appear to be function optimally, the rubber appears still from oxidation. It is recommended that the manufacturer provide an opinion as to how well the structure will function in this condition.

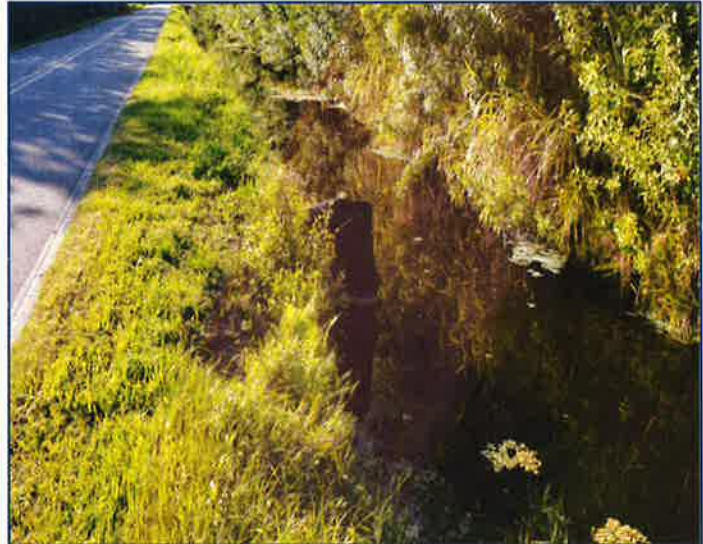
Field Photo

Field Visit Notes: Tideflex pipe end treatment. Tideflex product does not appear to be function optimally, the rubber appears still from oxidation. It is recommended that the manufacturer provide an opinion as to how well the structure will function in this condition.
