# Agenda Report

## New Business - Development and Environmental Services Group

J.2.

Authorization from the Board on Improvements at the Ritch Grissom Memorial Wetlands

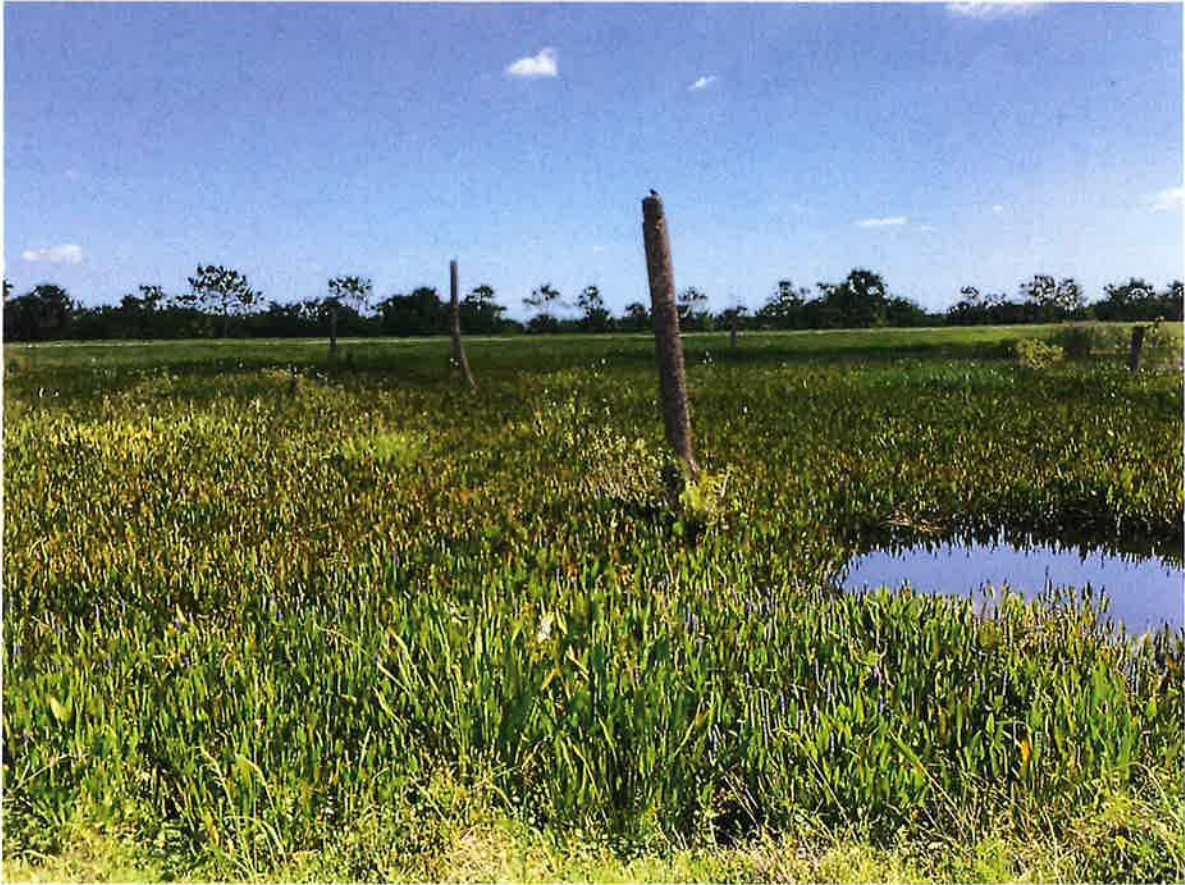
Pickerelweed and duck potato in equal distribution at Cell 4, Photo Station 2; facing north.

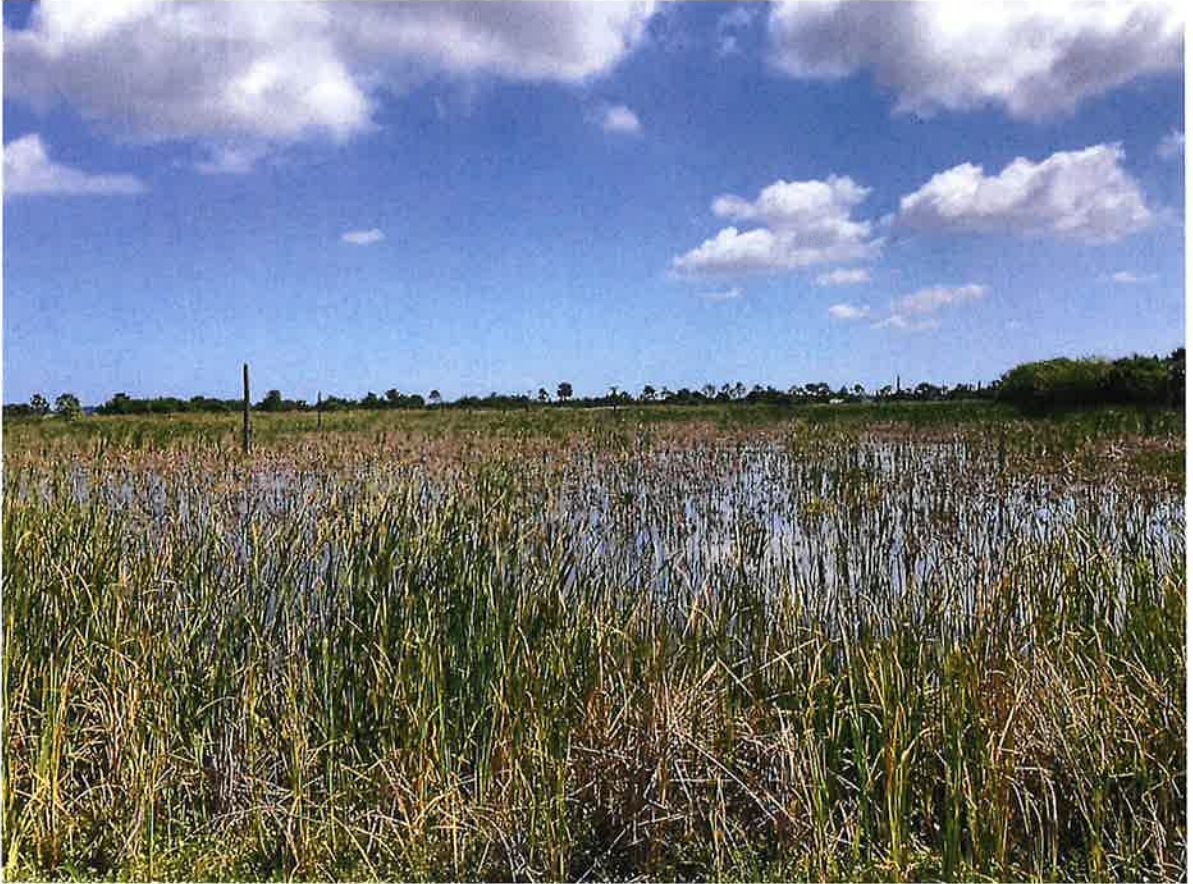
The assumption entering the project was the spraying of the cattails and leaving them in the system to decay was the root cause of the effluent water quality exceedances at WEP-1. The spray event occurred on May 11, 2020.

Living and dead cattails (from the spraying event) at Cell 4, Photo Station 5; facing northwest.

- Cease spraying of herbicide on cattail stands;
- Remove dead, decaying cattail stands;
- Herbicide spray monotypic areas of torpedo grass, allow to die back, then remove dead vegetation and underlying organic material;

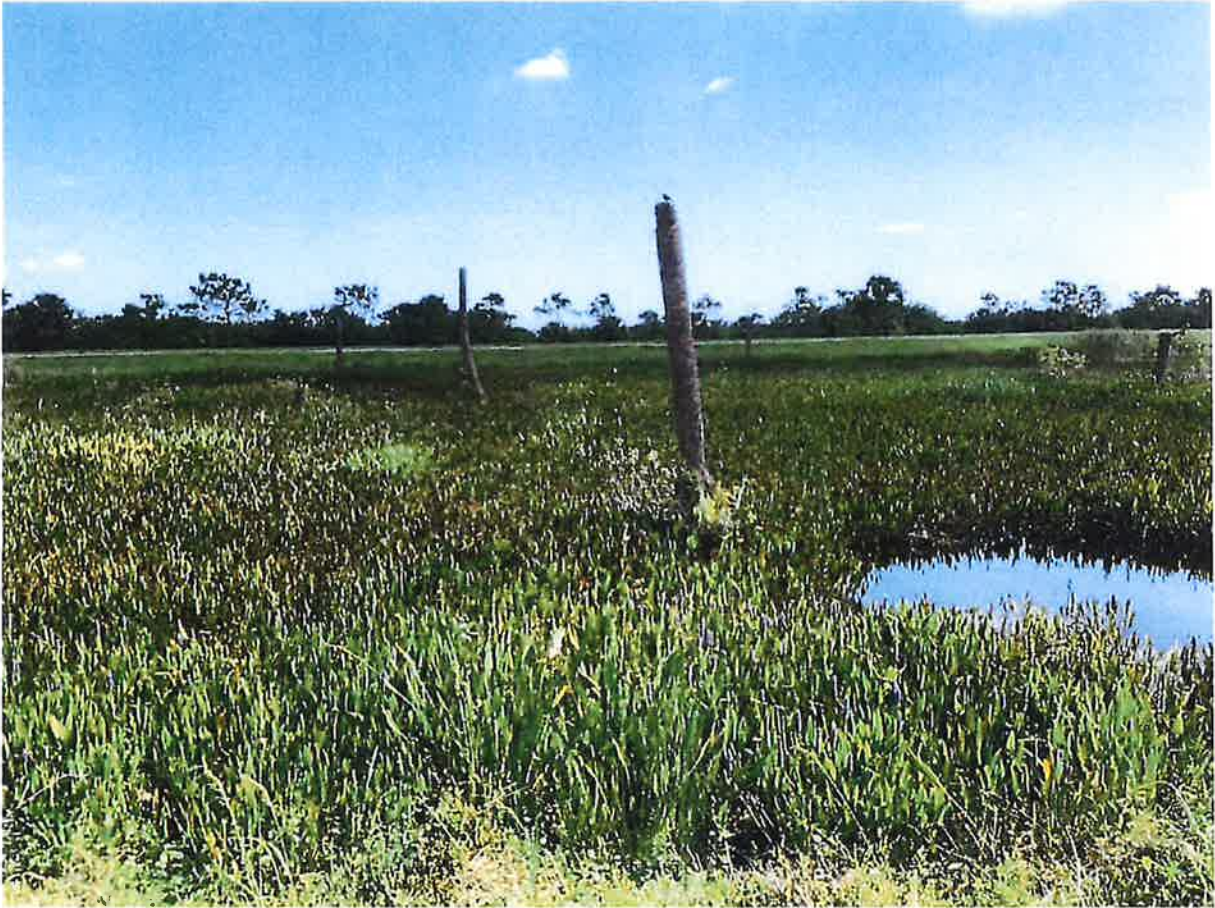
Pickerelweed and duck potato in equal distribution at Cell 4, Photo Station 2; facing north.

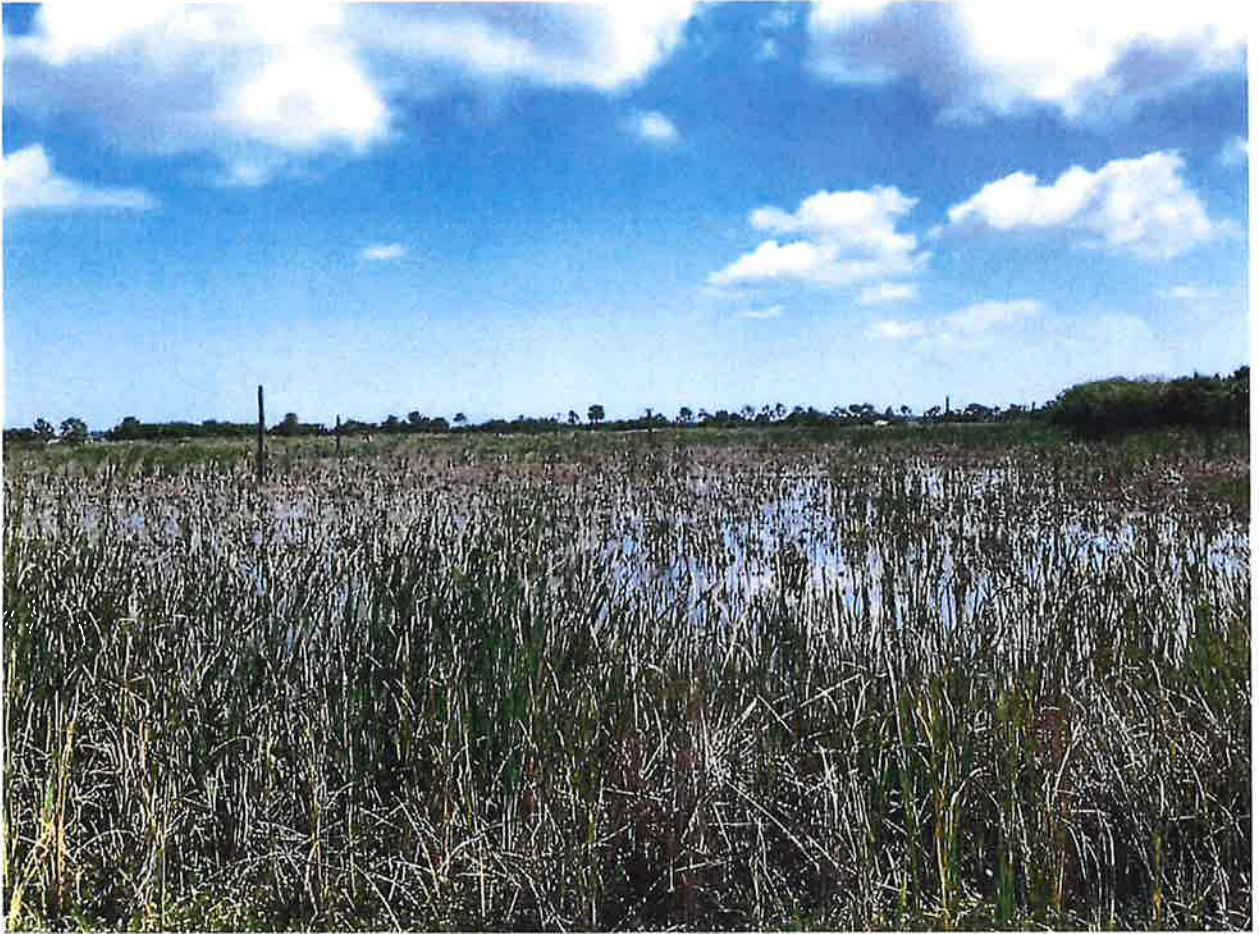
Living and dead cattails (from the spraying event) at Cell 4, Photo Station 5; facing northwest.

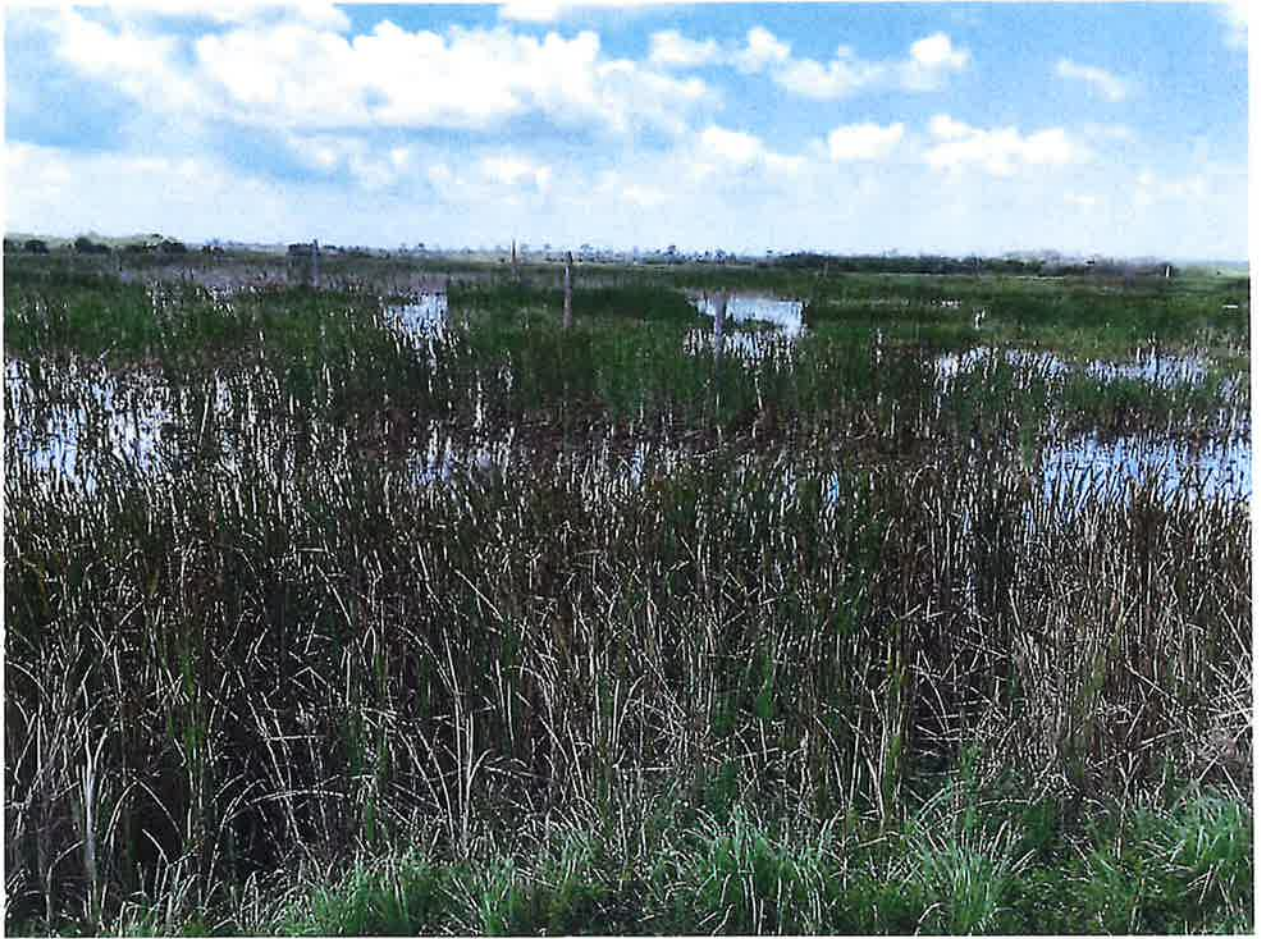
Living and dead cattails (from the spraying event) at Cell 4, Photo Station 9; facing south.
