# Agenda Report

## New Business - Development and Environmental Services Group

J.2.

Authorization from the Board on Improvements at the Ritch Grissom Memorial Wetlands

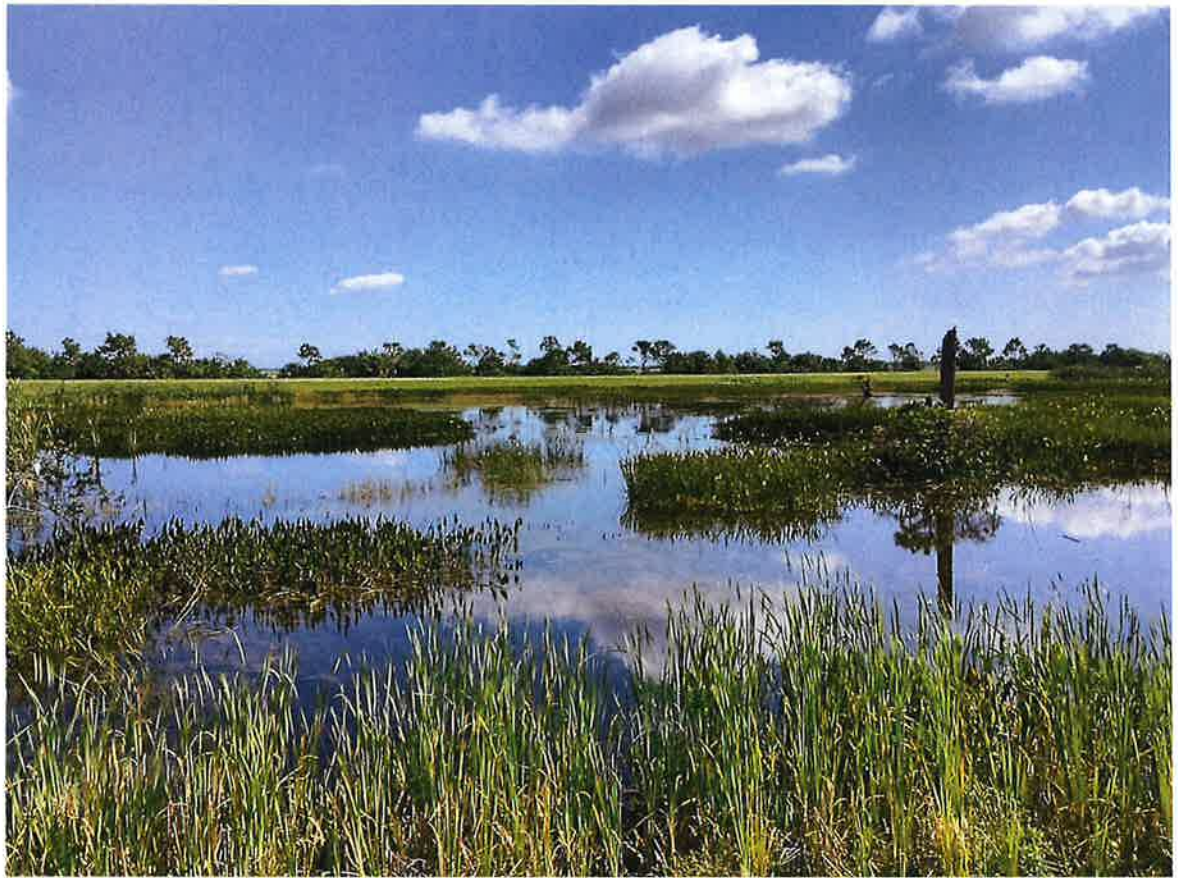
Open water and algal mats at Cell 4, Photo Station 3; facing northwest.

- Adopt a mechanical removal plan for excess filamentous algae, cattails, dead vegetation, and underlying organic material. This may include cutting of plant material and should include removal and disposal of all cut or observed floating or sinking detritus;

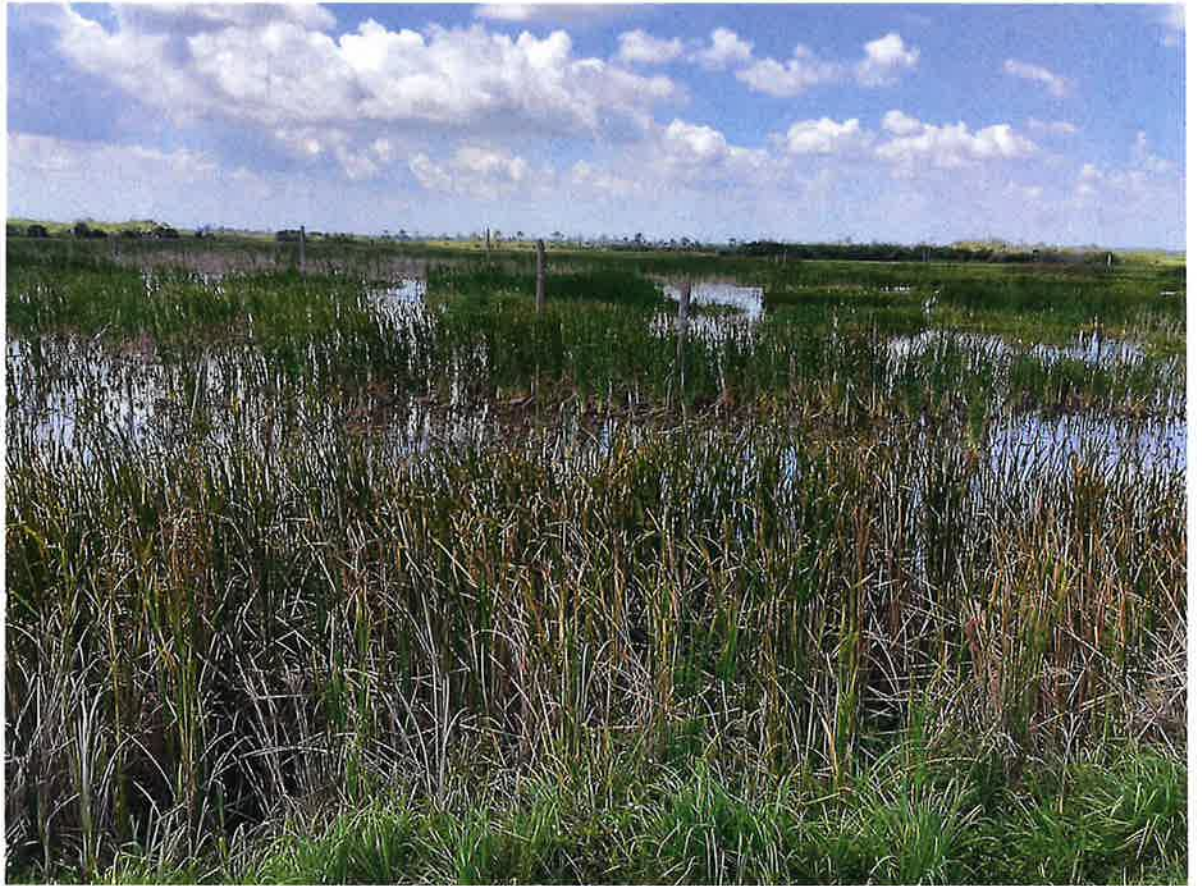
The assumption entering the project was the spraying of the cattails and leaving them in the system to decay was the root cause of the effluent water quality exceedances at WEP-1. The spray event occurred on May 11, 2020.

Living and dead cattails (from the spraying event) at Cell 4, Photo Station 9;  
facing south.

- Cease spraying of herbicide on cattail stands;
- Remove dead, decaying cattail stands;
- Herbicide spray monotypic areas of torpedo grass, allow to die back, then remove dead vegetation and underlying organic material;

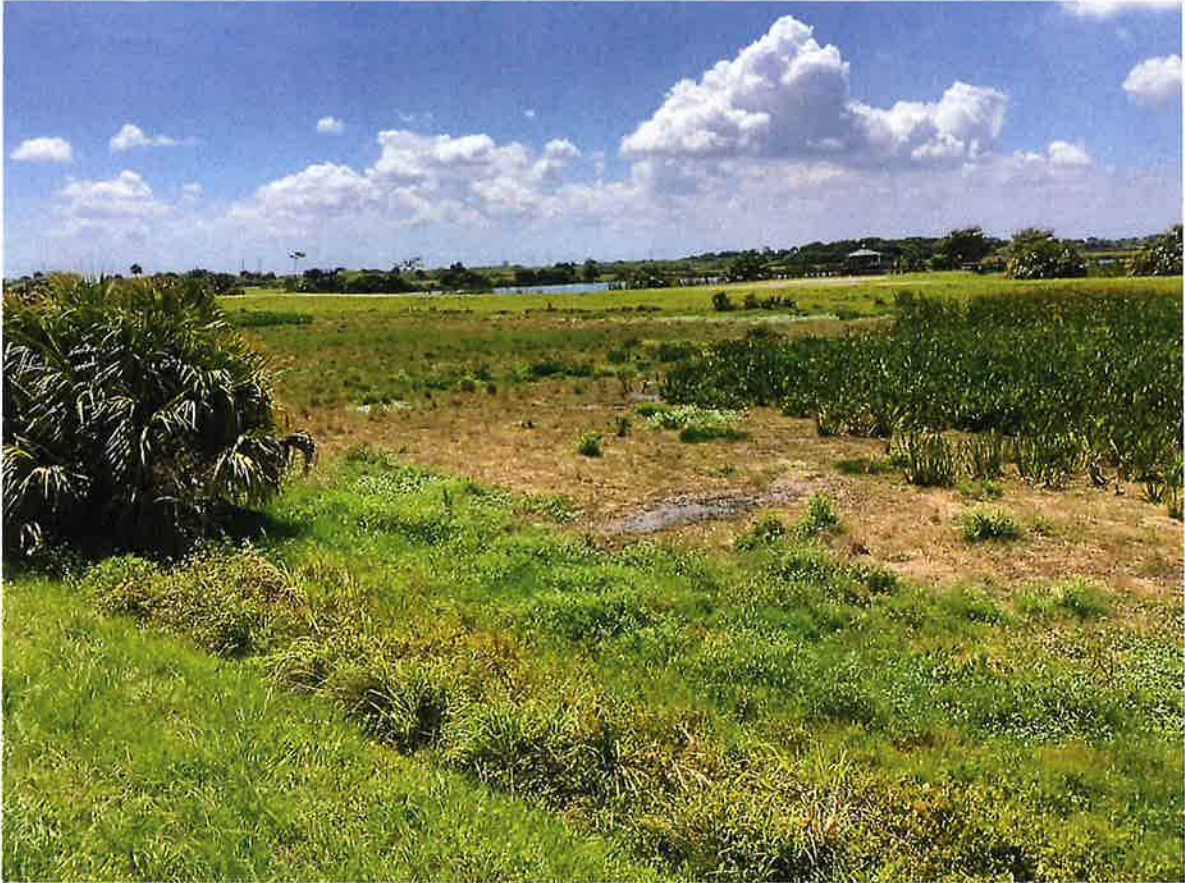
established on the bermed perimeter of the collective cells and documented via GPS. Fourteen photo stations (Dominant Vegetative Cover Map, PS 1-14) were established at Cell 4 and ten (Dominant Vegetative Cover Map, PS 15-24) were established at Cell 3. A vegetative assessment was then conducted at each photo station to determine the approximate percent coverage of each species, contributing to the Dominant Vegetative Cover Figure enclosed with this memo. The dominant species observed included cattail (*Typha* sp.), duck potato, and pickerelweed. Cattail dominated both cells, with both living and dead plants observed. The dead cattail covered approximately 12% of Cell 3 and 11% of Cell 4. Mixed and monotypic stands of cattail were observed in Cell 4, whereas the cattails in Cell 3 were solely monotypic stands. The green algae-like species was determined to be filamentous algae, observed in mats in the areas of open water in both cells. The increased presence of algae is likely due to the decaying material produced by the dead cattails. One area (approximately 0.7 acres) of torpedo grass (*Panicum repens*) was observed in Cell 4. According to the Florida Exotic Pest Plant Council Invasive Plant List, torpedo grass is considered a Category I invasive species.

Invasive torpedo grass at Cell 4, Photo Station 11; facing south.

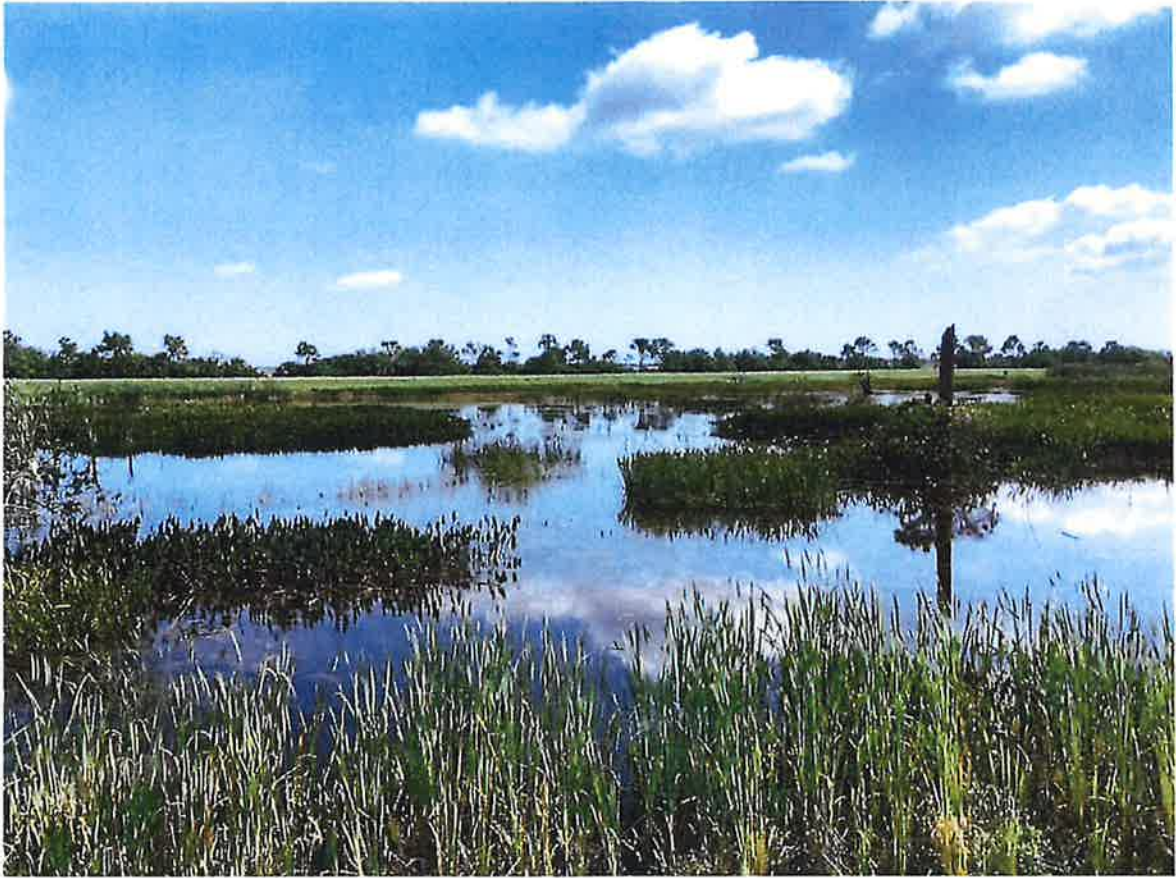
\* Open water and algal mats at Cell 4, Photo Station 3; facing northwest.

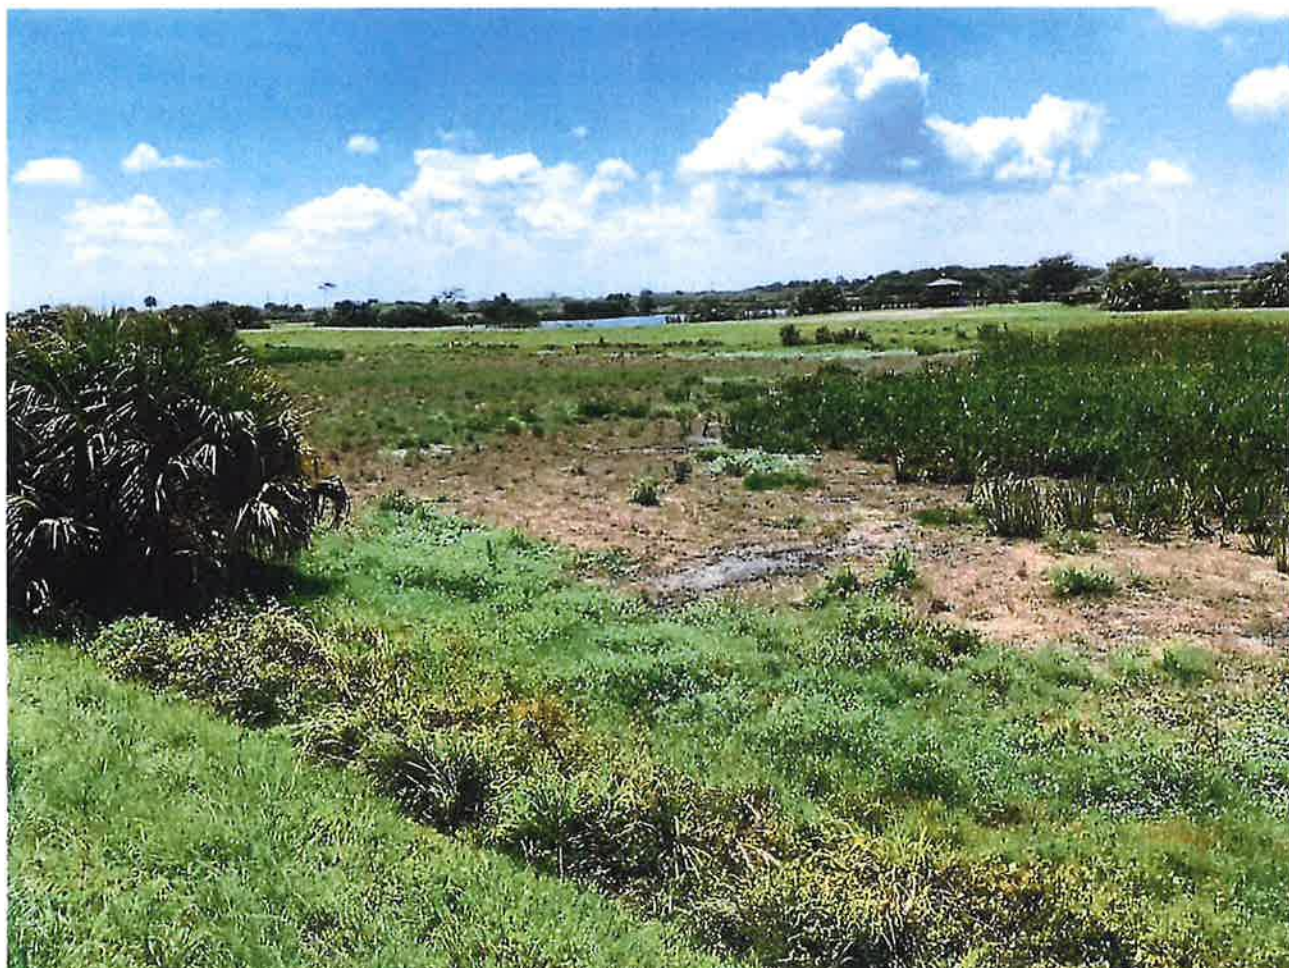
Invasive torpedo grass at Cell 4, Photo Station 11; facing south.

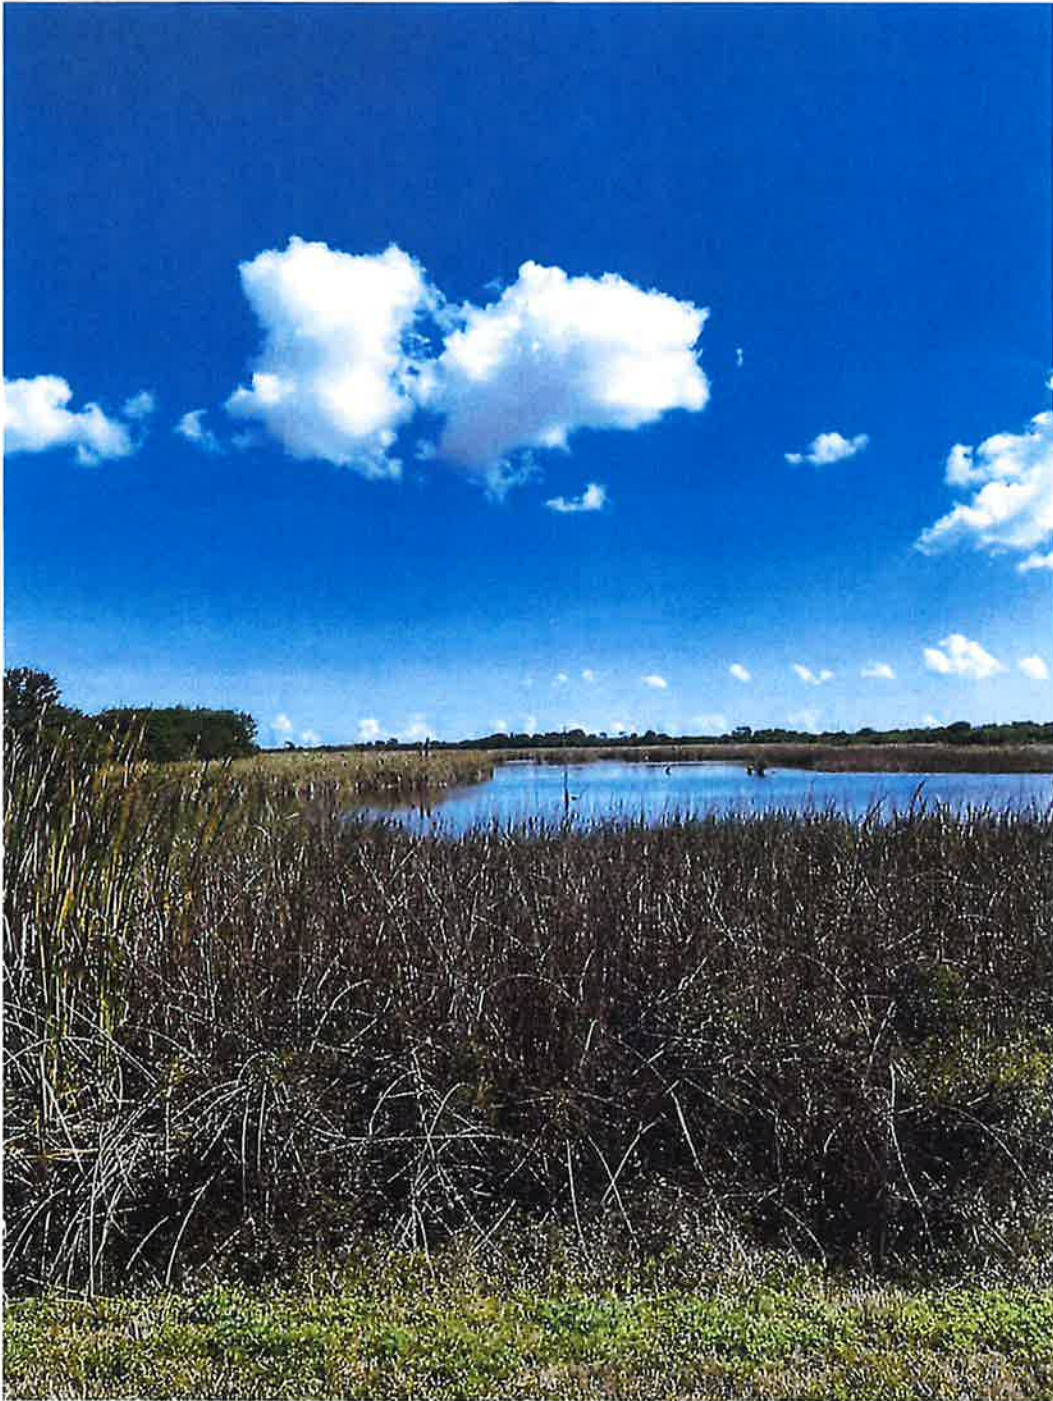
Cattails and bulrush with open water at Cell 1, Photo Station 4; facing east.

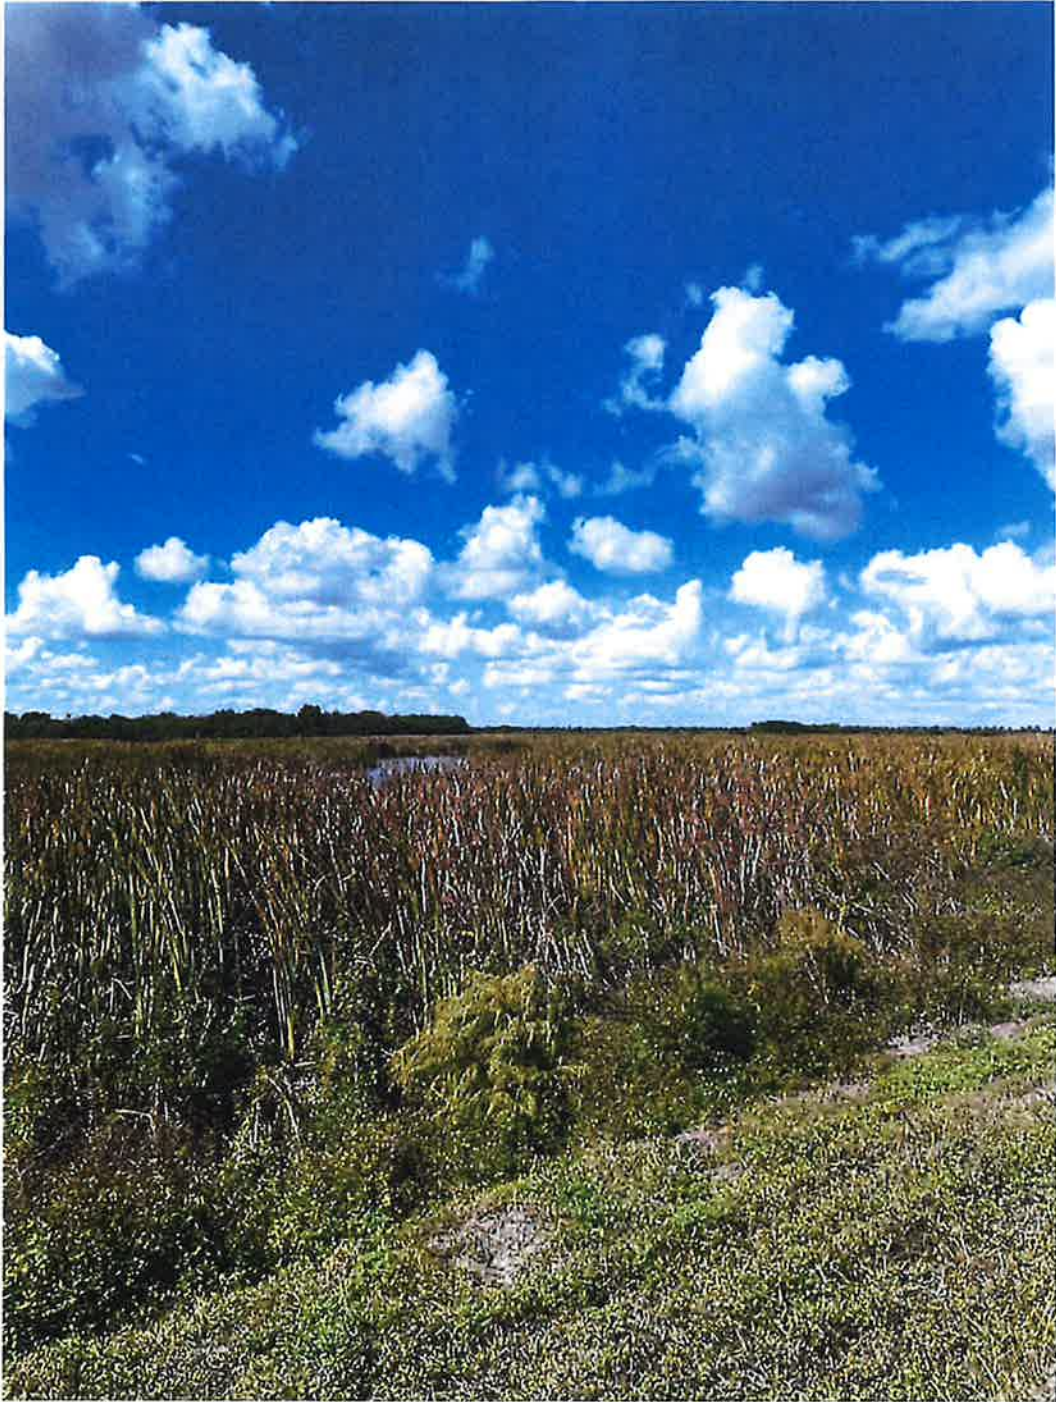
Living and dead cattails at Cell 1, Photo Station 9; facing west.

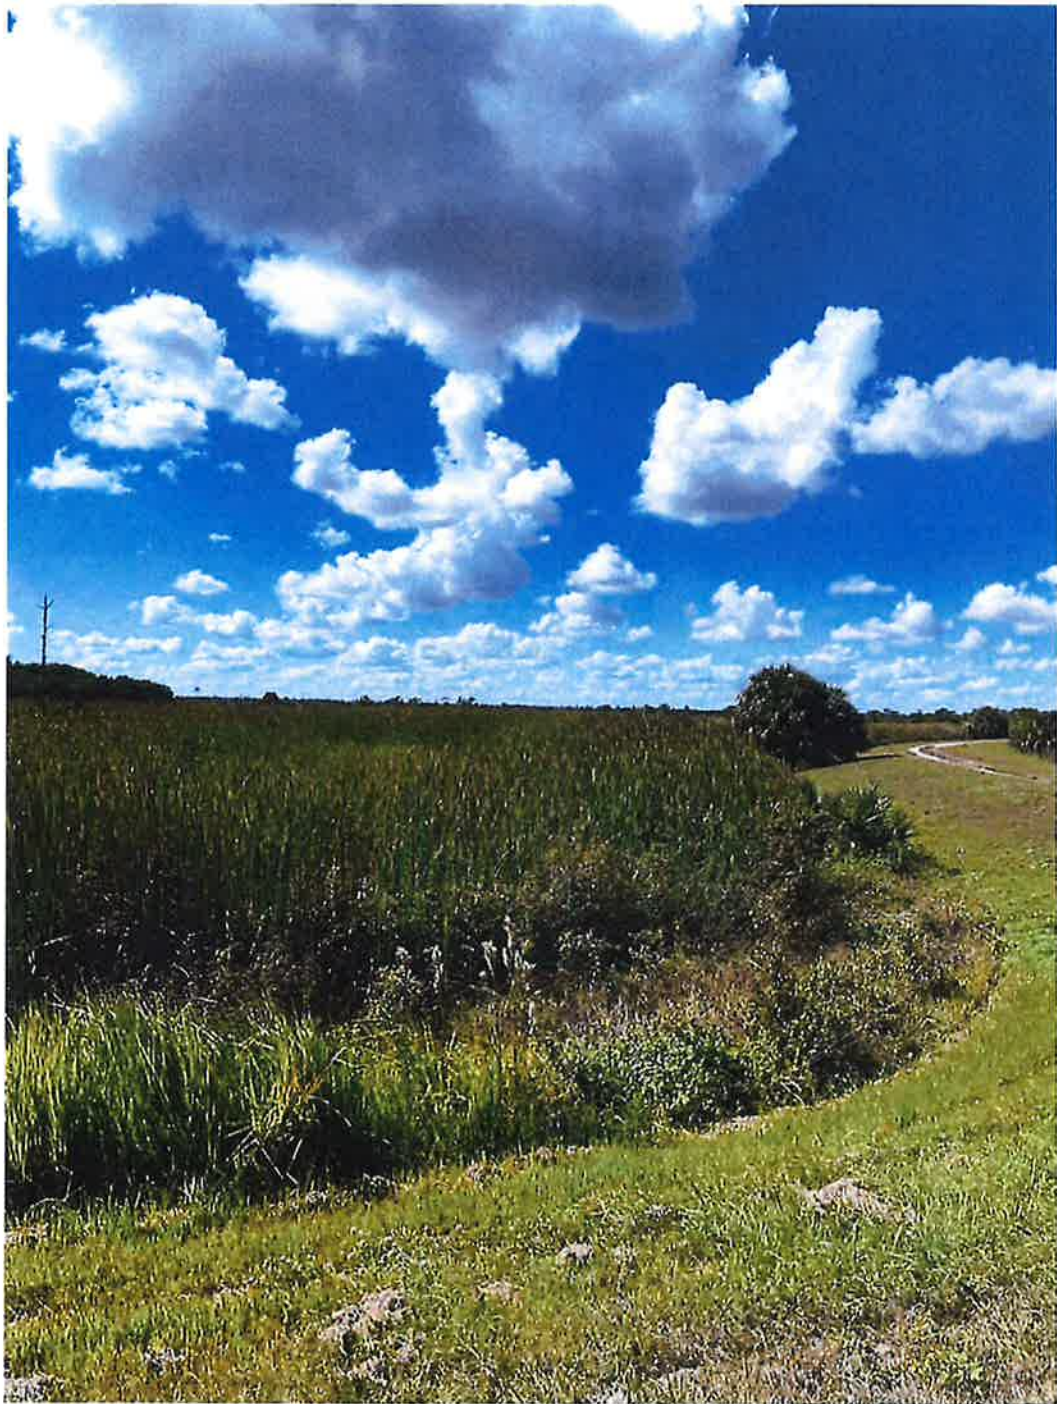
Cattails and cogon grass at Cell 1, Photo Station 13; facing west.

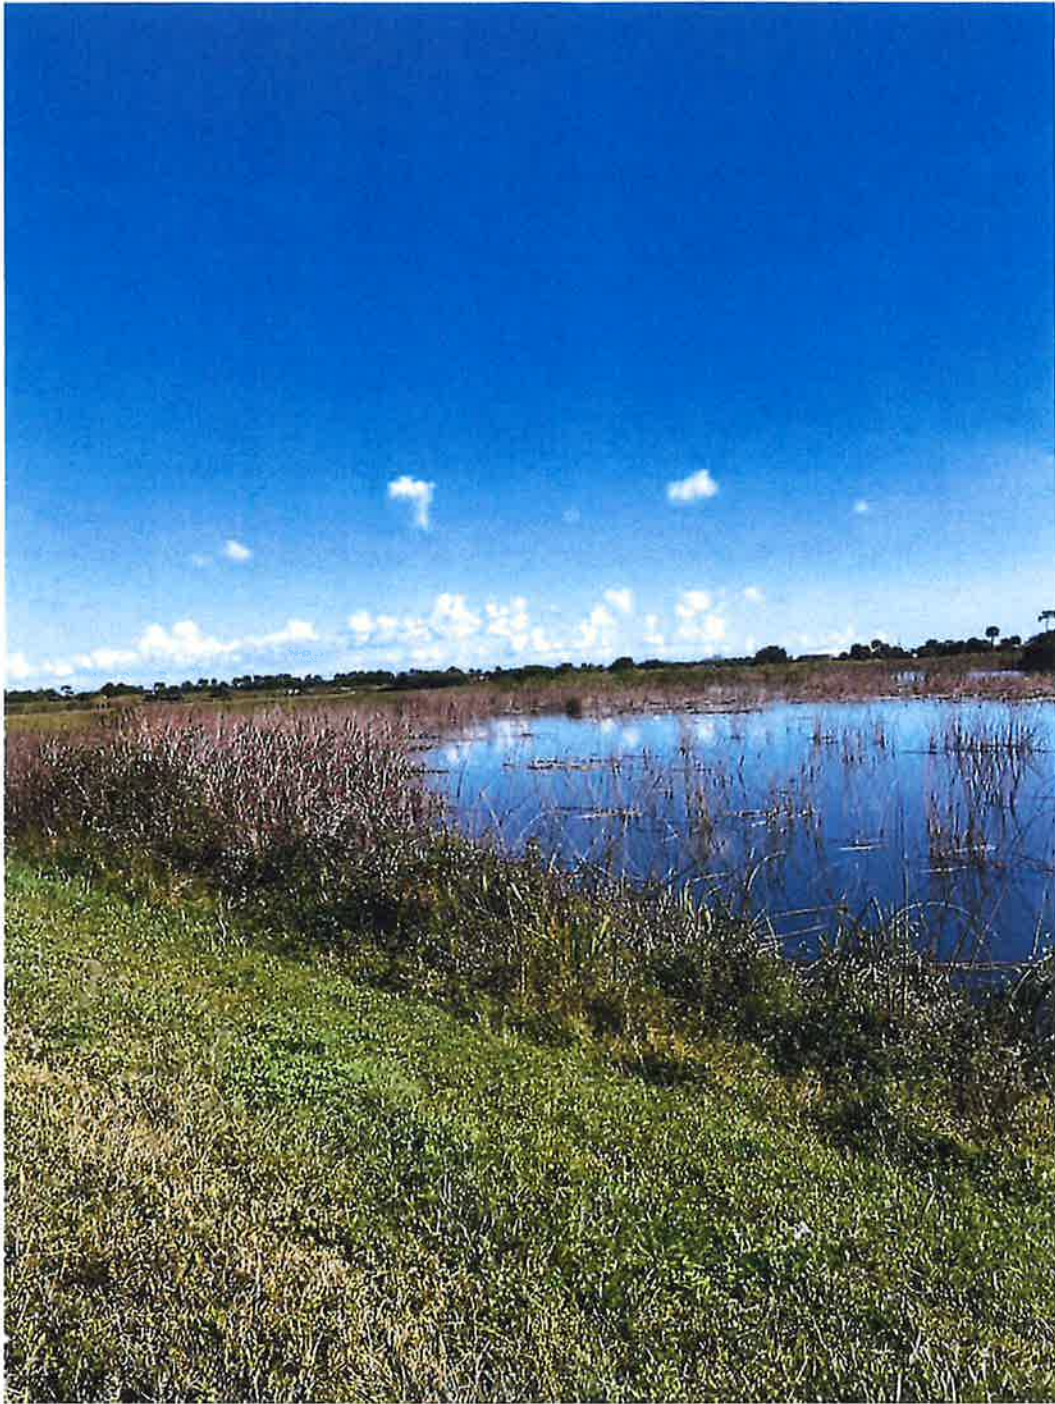
Cattails and bulrush at Cell 2, Photo Station 9; facing northeast.

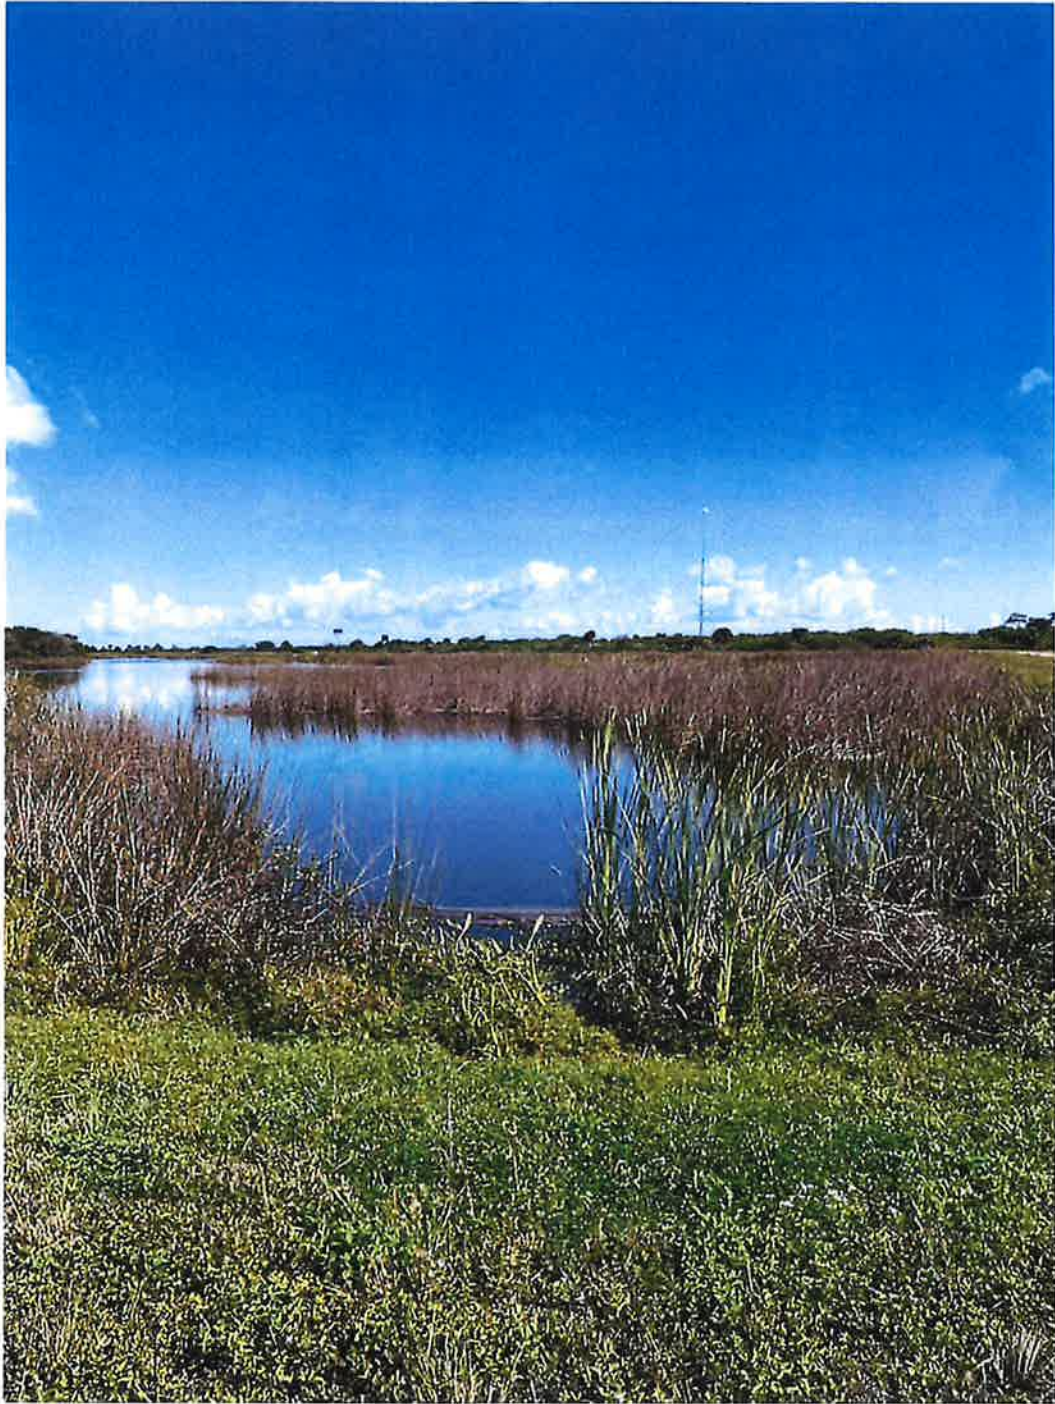
Living and dead cattails at Cell 2, Photo Station 14; facing north.

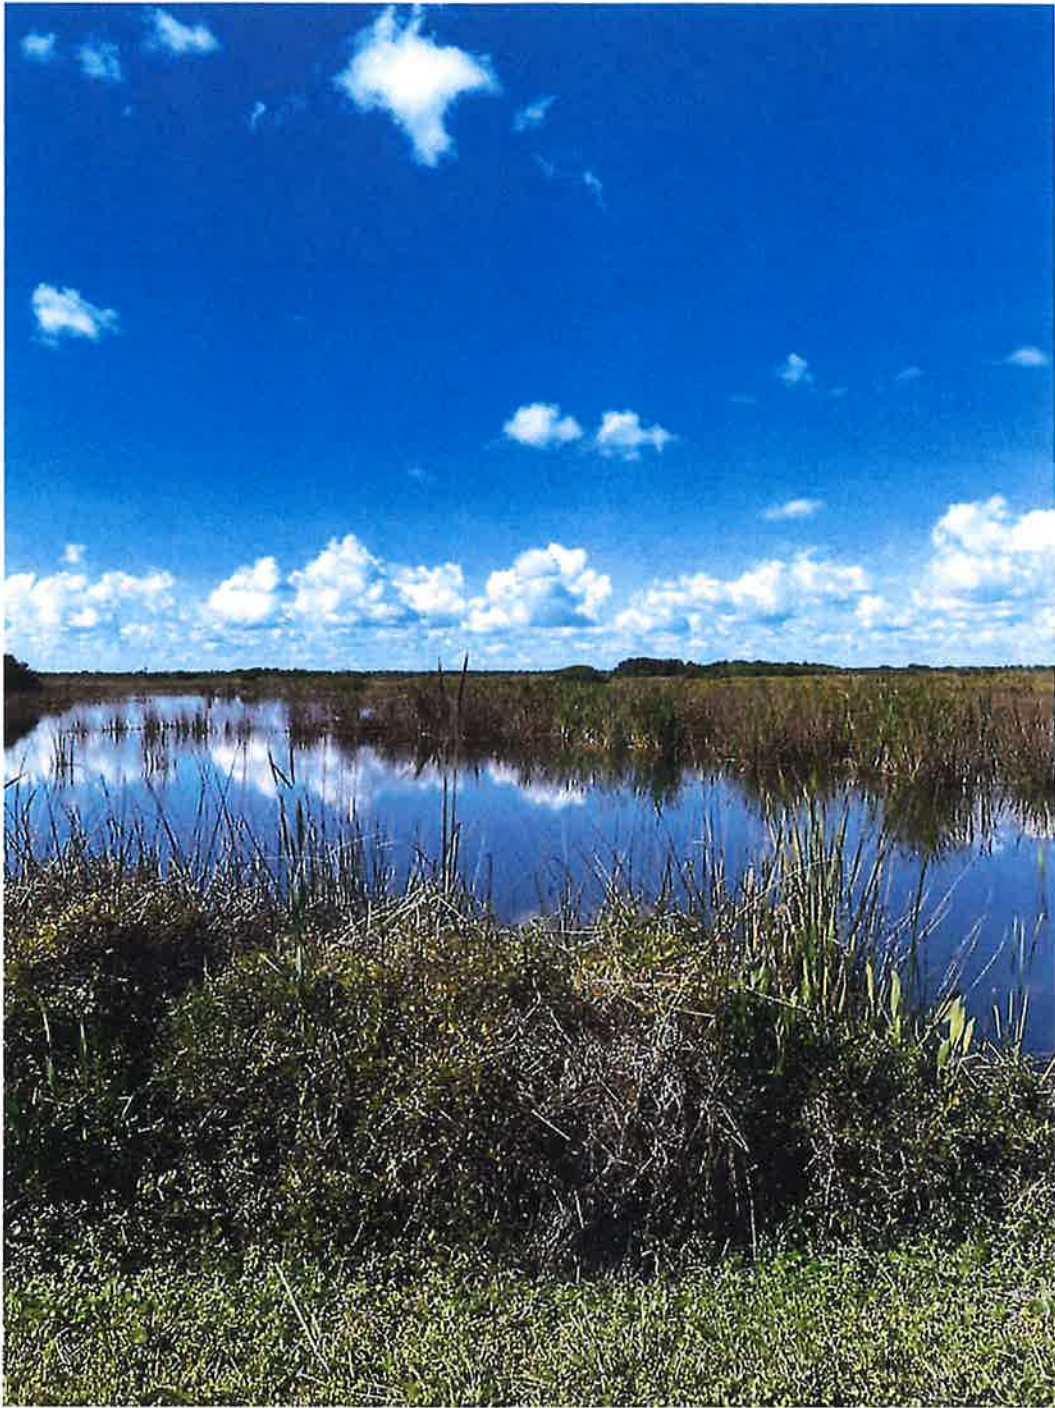
Bulrush and cattails at Cell 2, Photo Station 18; facing west.

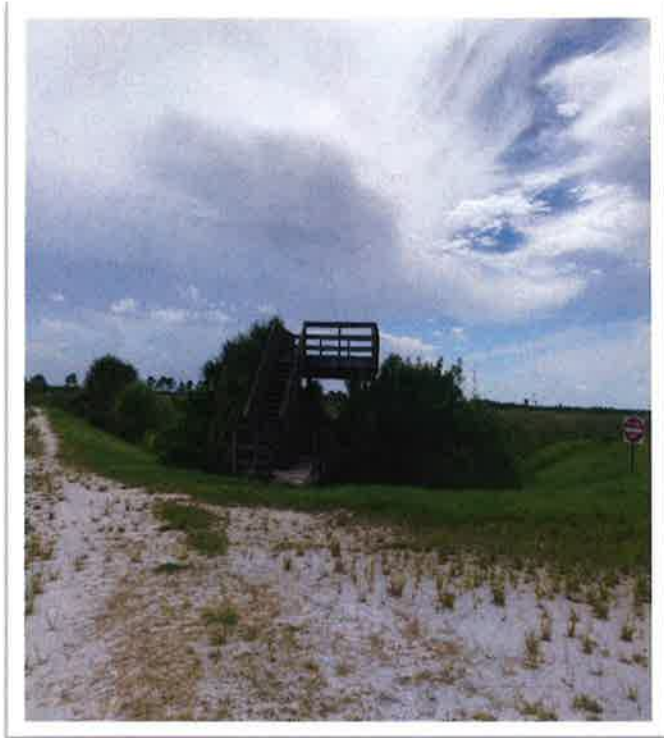
Stairs and deck railing and floor deck planks are in bad condition due to excessive moisture and weather.

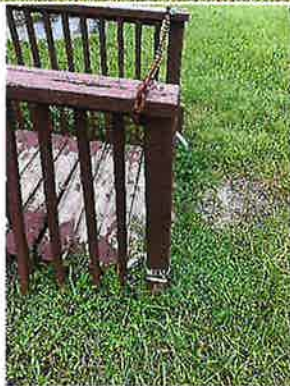
Picture 6  
Damaged walkway railing and walkway beam in bad condition.
